# The Chief Joseph Hatchery Program

## Okanogan River Adult Fish Pilot Weir

### *2019 Summary of Methods & Results*

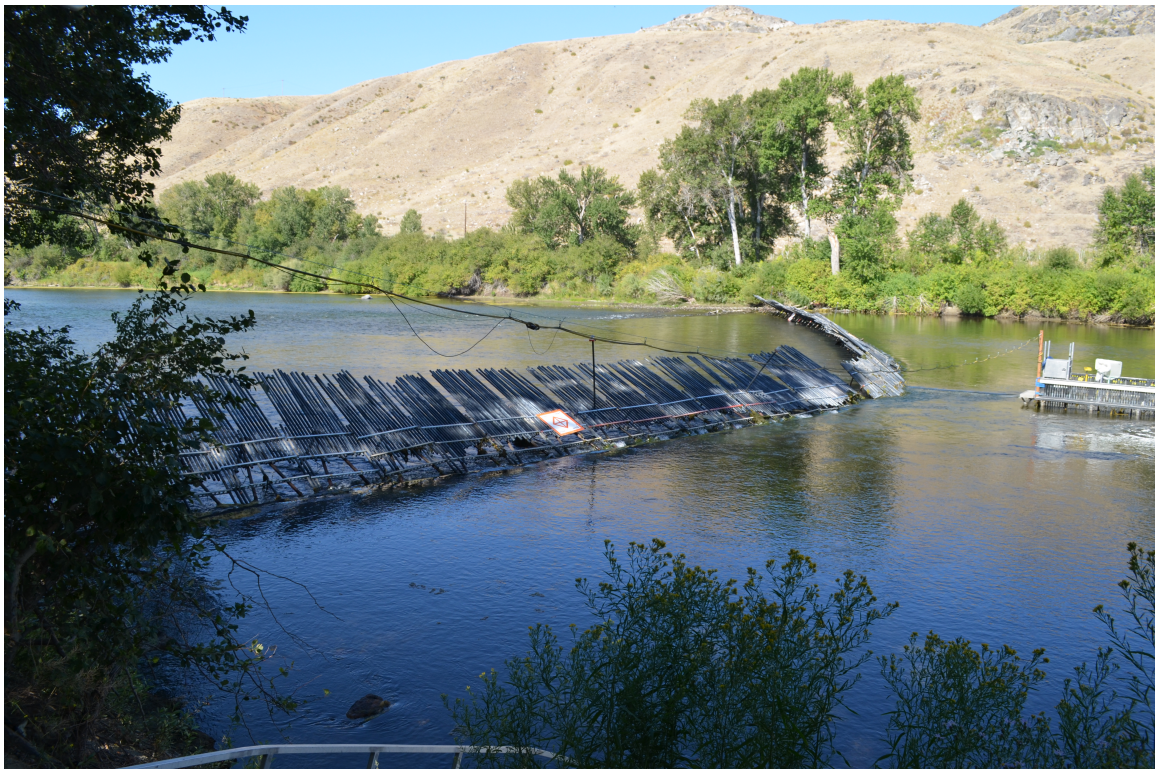
**Figure 1.** Lower Okanogan adult fish pilot weir, 2019. Photo taken in late- August..

The lower Okanogan fish weir was installed approximately 1.5 km downstream of Malott, WA (48°16’21.54 N; 119°43’31.98 W) in approximately the same location as previous years. Weir installation began on July 15th at a river flow of 1,540 cfs. and was completed with the underwater video system on July 19th. An aluminum trap was installed near the center of the channel at the downstream end of the deep pool in the thalweg of the channel. The trap was 3 m wide, 6 m long and 3 m high (Figure 1). A fifteen-foot aluminum accelerator chute was installed at the downstream trap gate. The wings of the weir stretched out from either side of the chute towards the river banks, angling downstream in a slight V configuration. The wings consisted of steel tripods with aluminum rails that supported the 3 m long Acrylonitrile butadiene styrene (ABS) pickets. Each panel was zip-tied to the adjacent panel for strength and stability. Gravel bags were placed between panels when needed to fill gaps that exceeded the target picket spacing. Picket spacing ranged from 2.5 to 5.1 cm. (1 to 2 inch) in 1.2 cm. (half-inch) increments (Figure 2). Pickets were manually forced into the river substrate upon deployment and then as needed to prevent fish passage under the weir.

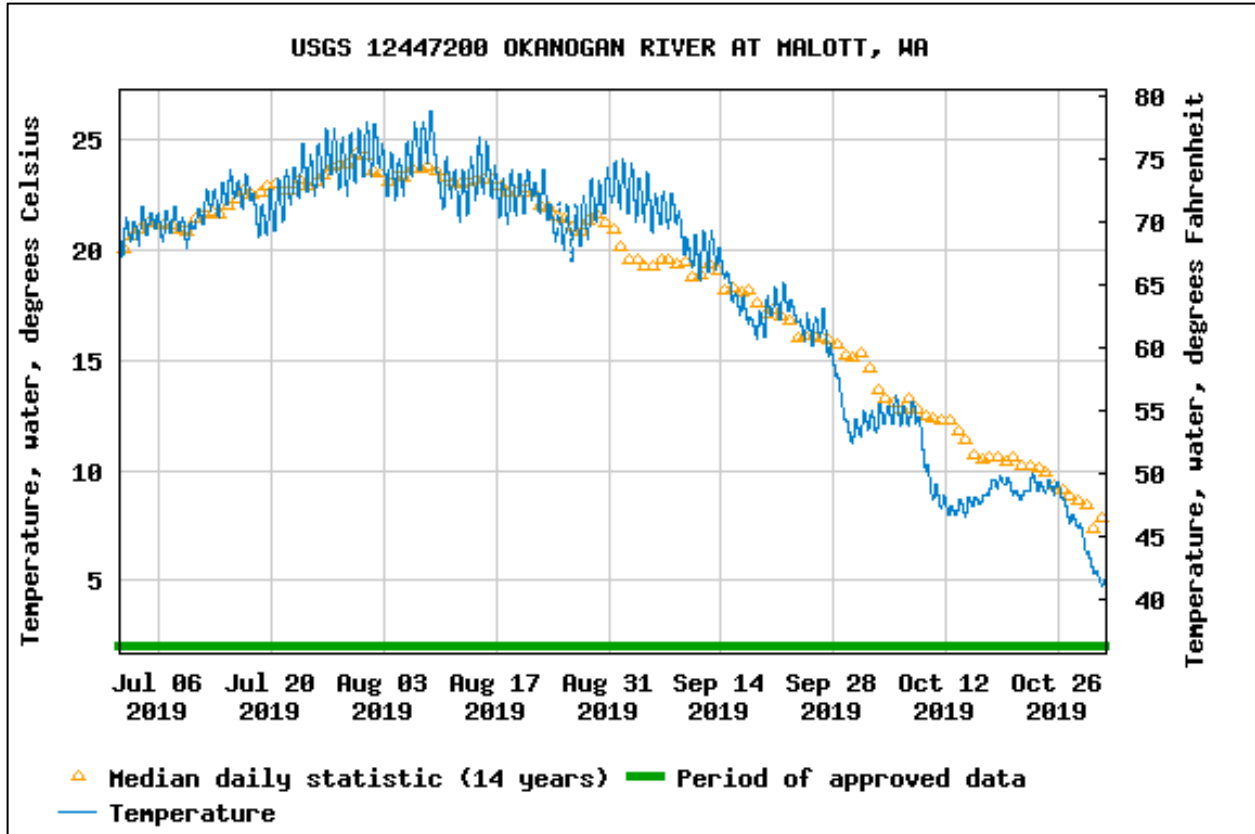
**Figure 4.** Temperature of the Okanogan River between July 1 and October 31, 2019. This figure was copied directly from the USGS website (<http://nwis.waterdata.usgs.gov/wa>).

Migration of sockeye and summer/fall Chinook is generally affected by a thermal barrier that is caused by warm water temperatures ( $\geq \sim 22$  °C) in the lower Okanogan River. The thermal barrier is dynamic within and between years, but generally it sets up in mid-July and breaks down in late August. In some years, the Okanogan River will temporarily cool off due to a combination of interrelated weather factors including rainstorms, cool weather, cloud cover or wildfire smoke. This 'break' in the thermal barrier can allow a portion of the fish holding in the Columbia River to enter the Okanogan and migrate up to thermal refuge in the Similkameen River or Lake Osoyoos. In 2019, temperatures were similar to the median daily temperatures from the last 13 years (Figure 4). Daily mean temperature was above 22.5 °C from July 1 to August 22. Daily mean temperature dropped below 22.5 °C on August 22<sup>nd</sup> and stayed below this mark until August 30<sup>th</sup>. Mean temperature dropped below the mark again on September 3<sup>rd</sup> and stayed below it for the rest of the season.

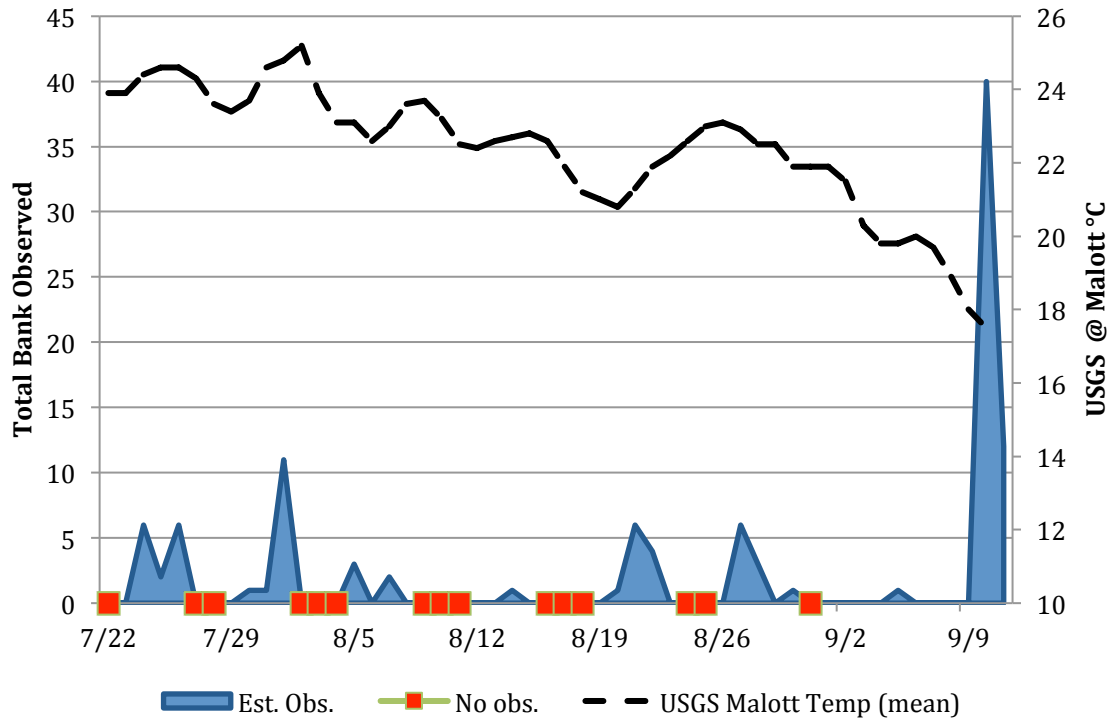
**Figure 5.** Estimate of Chinook observed from the bank at the lower pool, 0.8 km downstream of the weir.

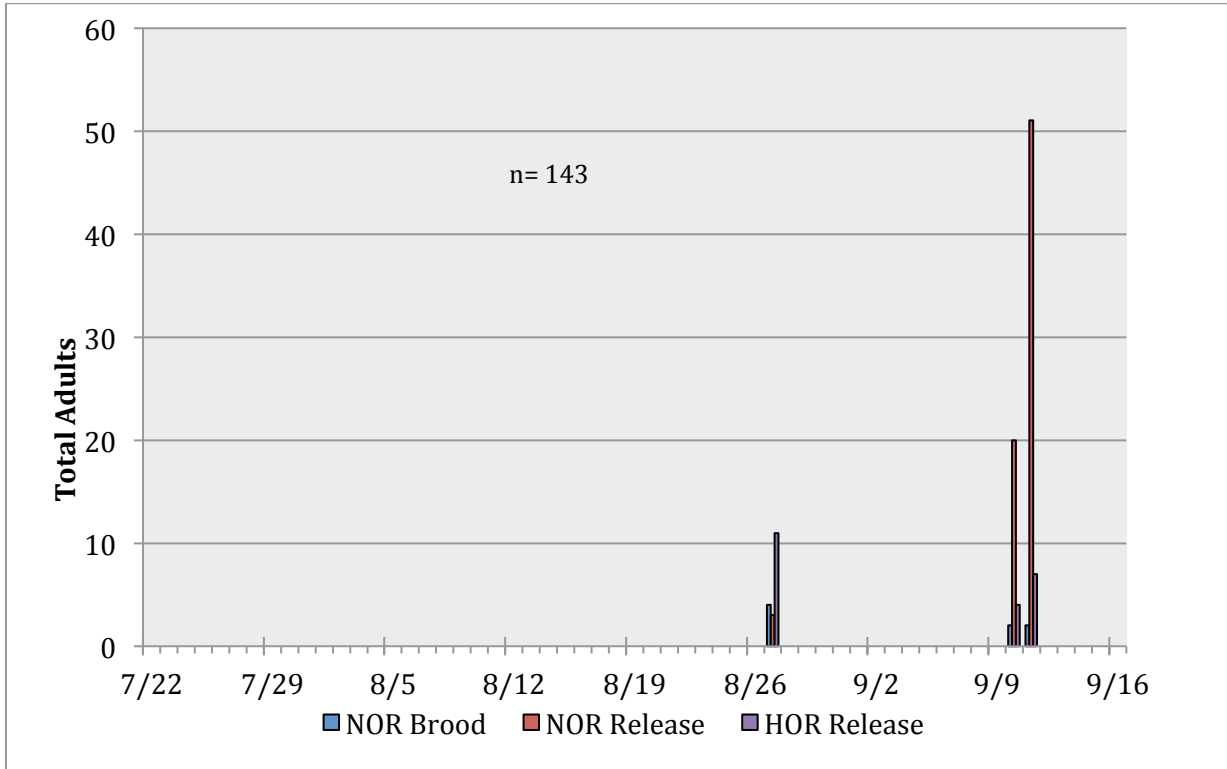
**Figure 9.** Final destination of Chinook adults captured in the weir trap during trapping operations in 2019.

Tower observations showed that most fish were equally distributed across the river, milling in the river right, left and center sections (looking downstream). Estimates were quite a bit lower than previous season, especially during the month of August when the pickets were lifted. Estimates were highest during the last week of the weir season when mean daily river temperatures dropped below 22.5 °C and the majority of fish were trapped. Bank observations showed that the number fish observed holding in the lower pool, 0.8 km below the weir, increased about one week after the thermal barrier breakdown in September (Figure 5). Trapping operations were conducted on August 26-27 and September 9-11 when river temperature was  $\leq 22.5$  °C. The total fish trapped at the weir in 2019 was 159 with 90% of them being Chinook salmon (Figure 6). Ninety-three percent of the Chinook trapped were released back into the river (Figure 7). No steelhead were trapped in 2019..
