The Chief Joseph Hatchery Program

Okanogan River Adult Fish Pilot Weir

2021 Summary of Methods & Results

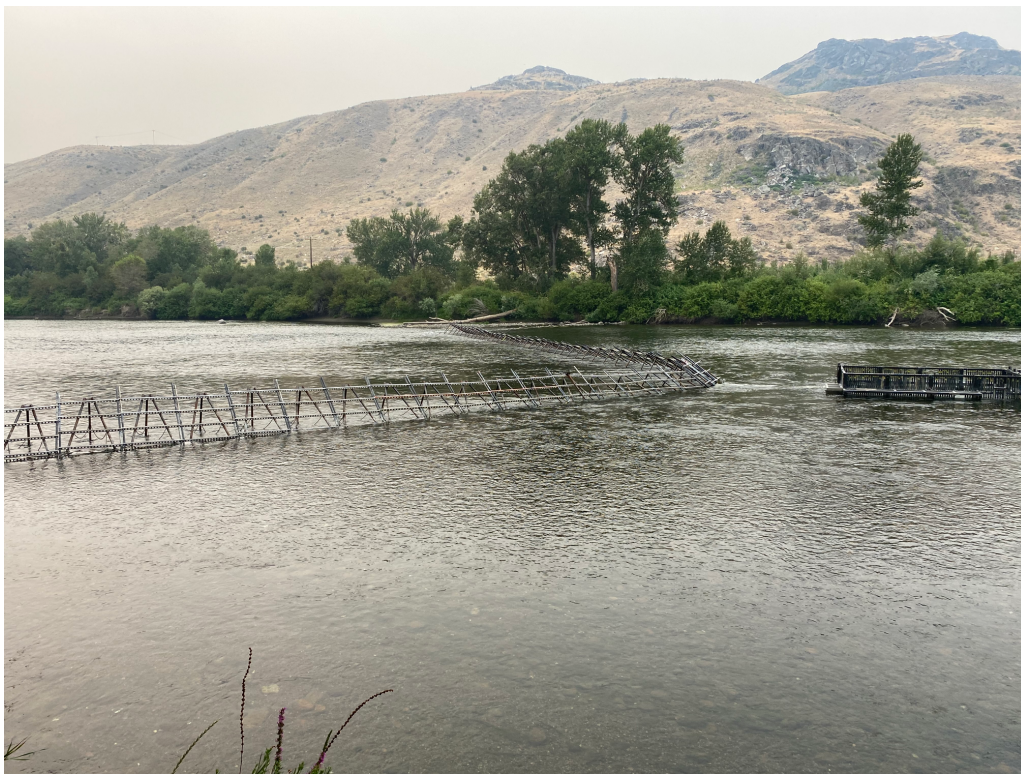
Figure 1. Lower Okanogan adult fish pilot weir, 2021. Photo taken in early August during deployment.

The lower Okanogan fish weir was installed approximately 1.5 km downstream of Malott, WA (48°16’21.54 N; 119°43’31.98 W) in approximately the same location as previous years. Weir installation began on August 2nd at a river flow of 927 cfs. and was completed with the underwater video system on August 10th. An aluminum trap was installed near the center of the channel at the downstream end of the deep pool in the thalweg of the channel. The trap was 3 m wide, 6 m long and 3 m high (Figure 1). A fifteen-foot aluminum accelerator chute was installed at the downstream trap gate. The wings of the weir stretched out from either side of the chute towards the riverbanks, angling downstream in a slight V configuration. The wings consisted of steel tripods with aluminum rails that supported the 3 m long Acrylonitrile butadiene styrene (ABS) pickets. Each panel was zip-tied to the adjacent panel for strength and stability. Gravel bags were placed between panels when needed to fill gaps that exceeded the target picket spacing. Picket spacings included 2.5 cm (1 inch) and 5.1 cm (2 inch) sizes (Figure 2). Pickets were manually forced into the river substrate upon deployment and then as needed to prevent fish passage under the weir.

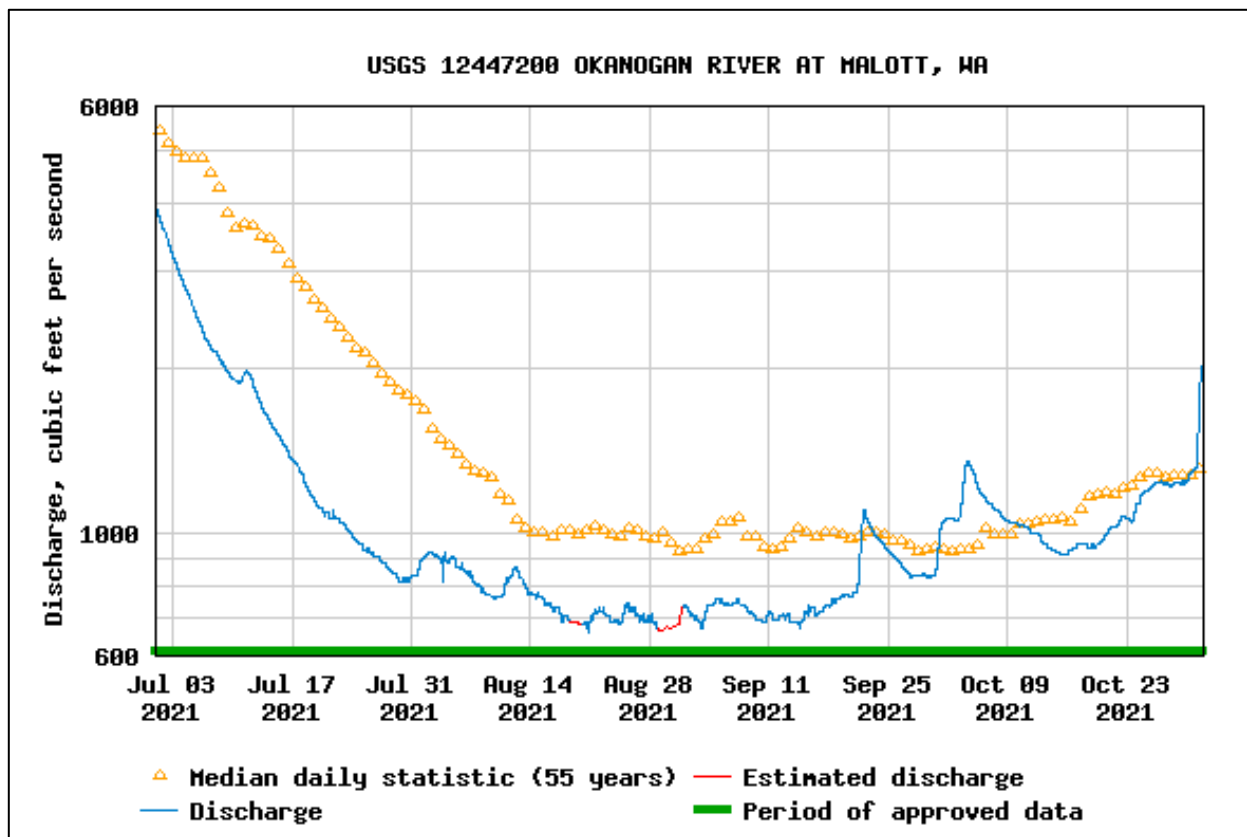
Figure 3. Discharge of the Okanogan River between July 1 and October 31, 2021. This figure was copied directly from the USGS website (<http://nwis.waterdata.usgs.gov/wa>).

The Okanogan River (at Malott) discharge was below normal in 2021 which allowed for deployment of the weir to start on August 2nd with the river flow at 927 cfs (Figure 3). Discharge continued to drop throughout the season and was approximately 828 cfs by the time the weir was removed for the season on September 29.

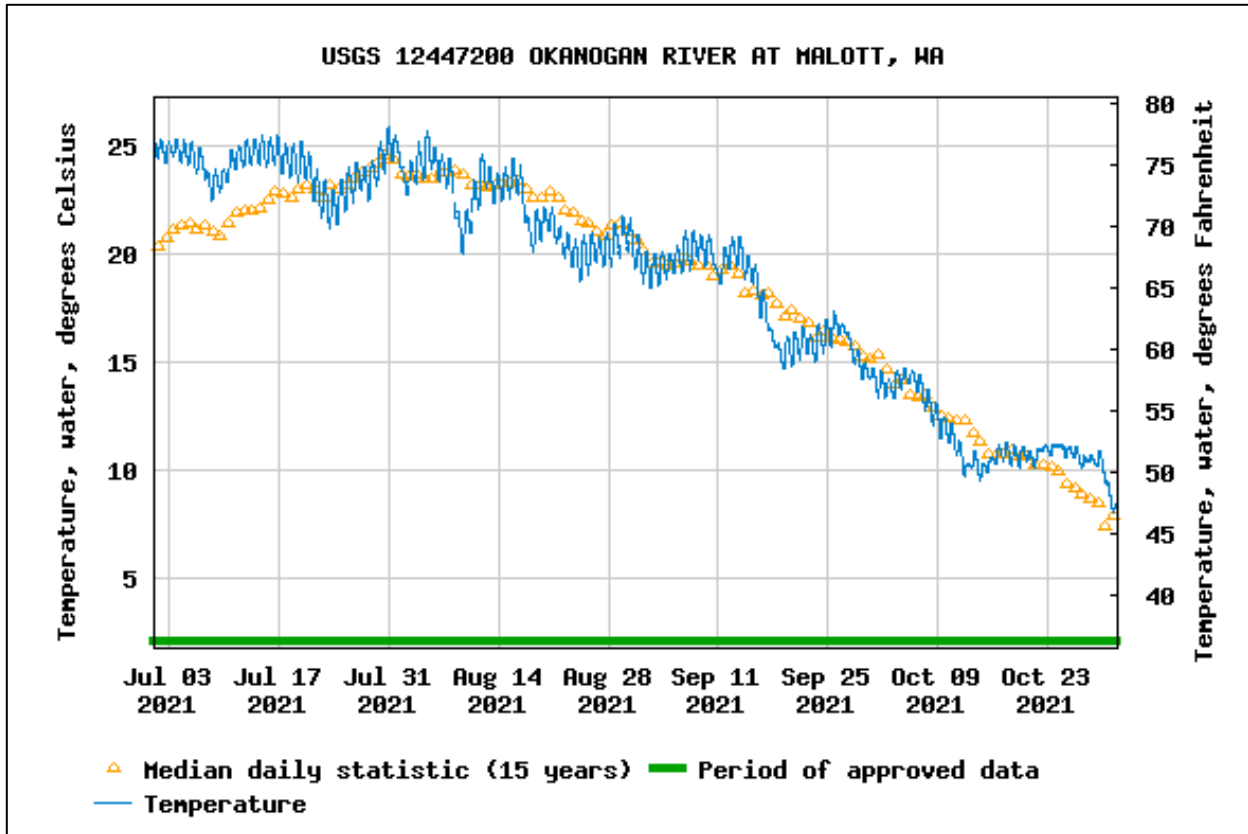
Figure 4. Temperature of the Okanogan River between July 1 and October 31, 2021. This figure was copied directly from the USGS website (<http://nwis.waterdata.usgs.gov/wa>).

River. The thermal barrier is dynamic within and between years, but it generally sets up in mid-July and breaks down in late August. In some years, the Okanogan River will temporarily cool off due to a combination of interrelated weather factors including rainstorms, cool weather, cloud cover and/or wildfire smoke. This 'break' in the thermal barrier can allow a portion of the fish holding in the Columbia River to enter the Okanogan and migrate up to thermal refuge in the Similkameen River or Lake Osoyoos. In 2021, temperatures were similar to the median daily temperatures from the last 15 years (Figure 4). Daily mean temperature was above 22.5 °C from July 1-July 22 and then dropped below it for a couple days before it went back above it from July 25- August 7. The temperature went back below for a couple more days then went back above the threshold for 6 more days from August 11-16. On August 17 the thermal barrier broke down and stayed below the 22.5 °C for the rest of the season.

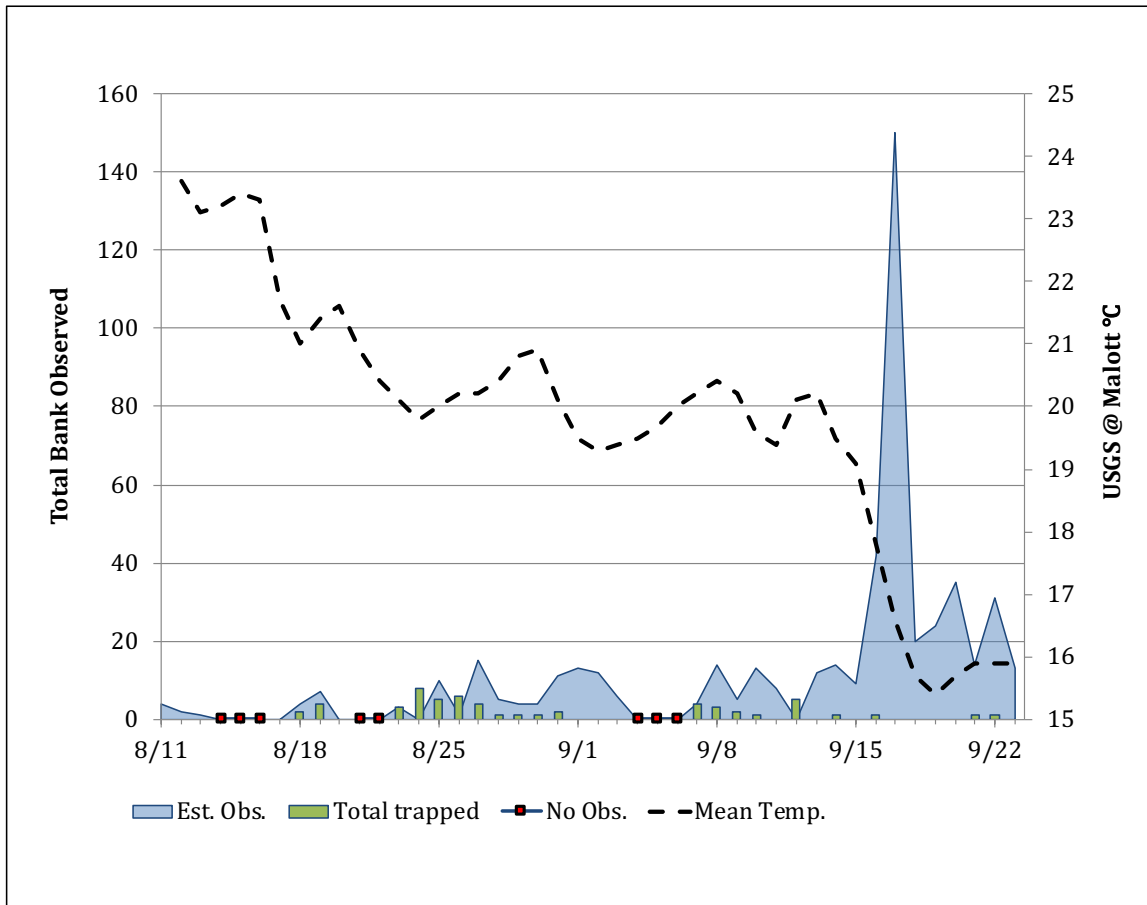
Figure 5. Estimate of Chinook observed from the bank at the lower pool, 0.8 km downstream of the weir.

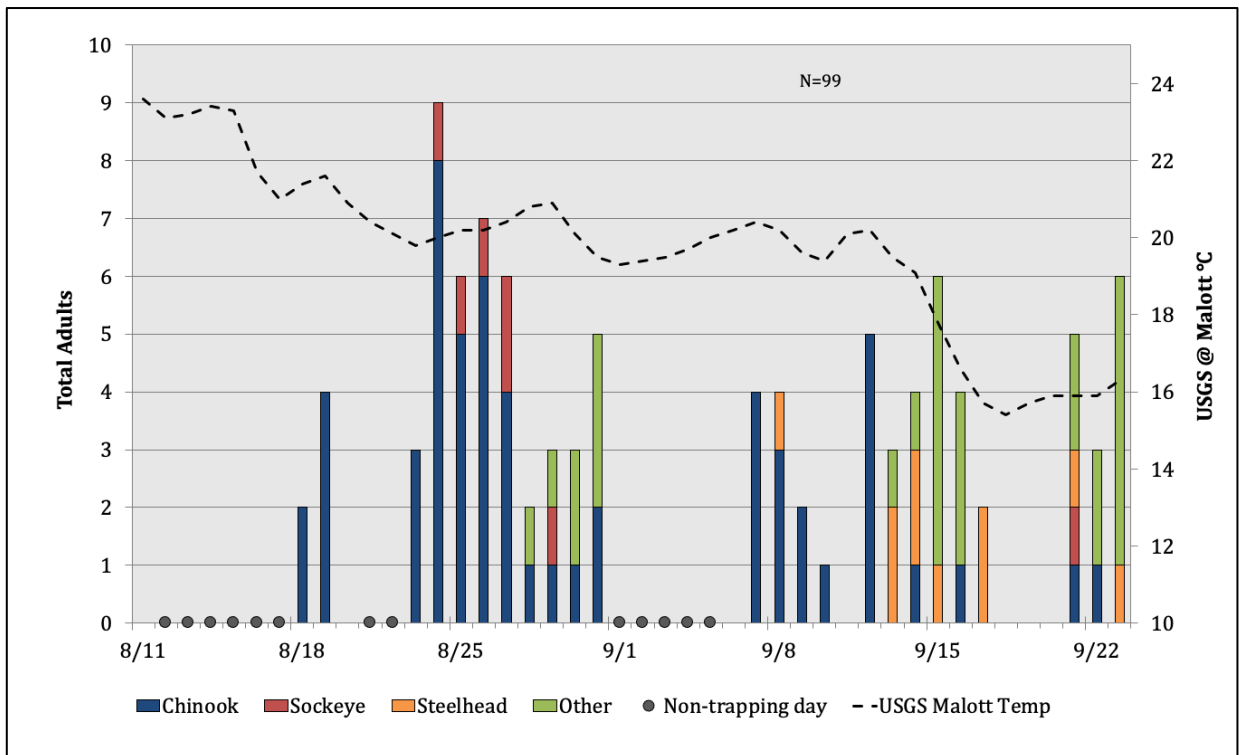
Figure 6. Total number of fish trapped at the Okanogan weir in 2021.
