The Chief Joseph Hatchery Program

Okanogan River Adult Fish Pilot Weir

2014 Summary of Results & Methods

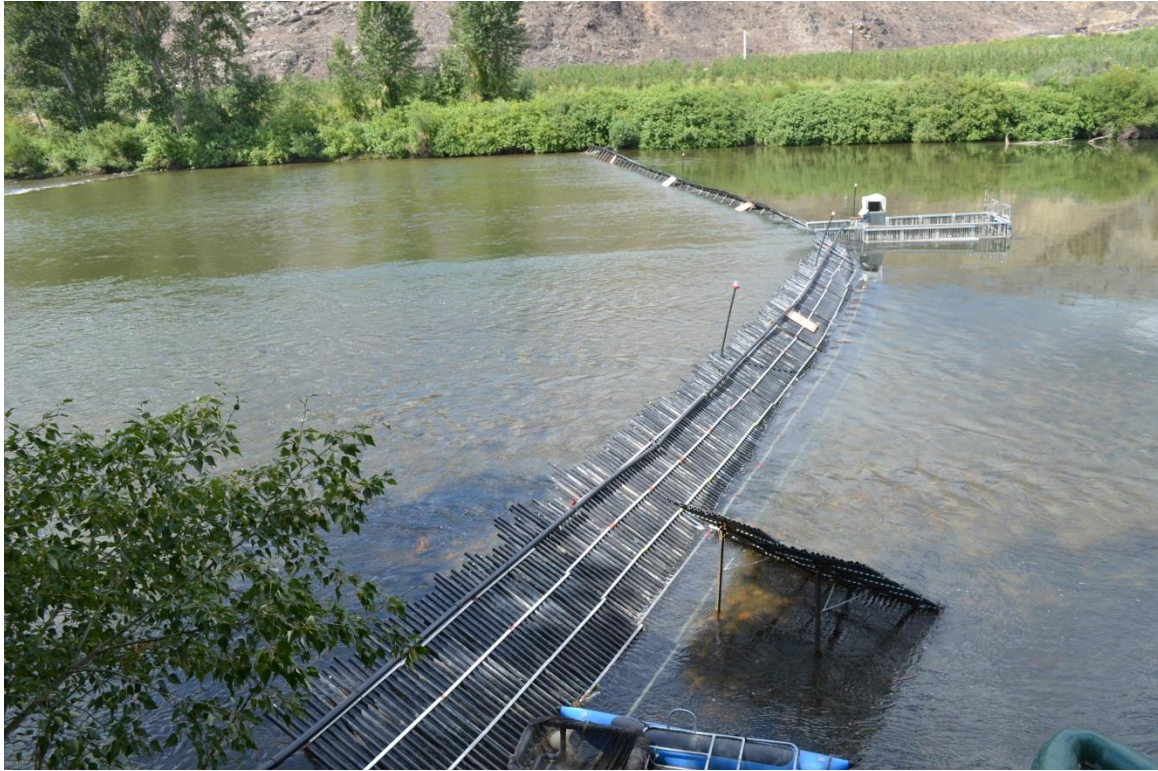
Figure 1. Lower Okanogan adult fish pilot weir, 2014.

The lower Okanogan fish weir was installed approximately 1.5 km downstream of Malott, WA (48°16'21.54 N; 119°43'31.98 W). Weir installation began on August 4th at a river flow of 1,360 cfs and was complete on August 11th. An aluminum trap was installed near the center of the channel at the upstream end of the deep pool in the thalweg of the channel. The trap was 3 m wide, 6 m long and 3 m high (Figure 1). The wings of the weir stretched out from either side of the trap towards the river banks. The wings consisted of steel tripods with aluminum rails that supported the 3 m long Acrylonitrile butadiene styrene (ABS) pickets. Each panel was zip-tied to the adjacent panel for strength and stability. Sand bags were placed at the base to support the tripod legs and between panels when needed to fill gaps that exceeded the target picket spacing. Picket spacing ranged from 2.5 to 7.6 cm (1 to 3 inch) in 1.2 cm (half-inch) increments (Figure 2). Pickets were manually forced into the river substrate daily to prevent fish passage under the weir.

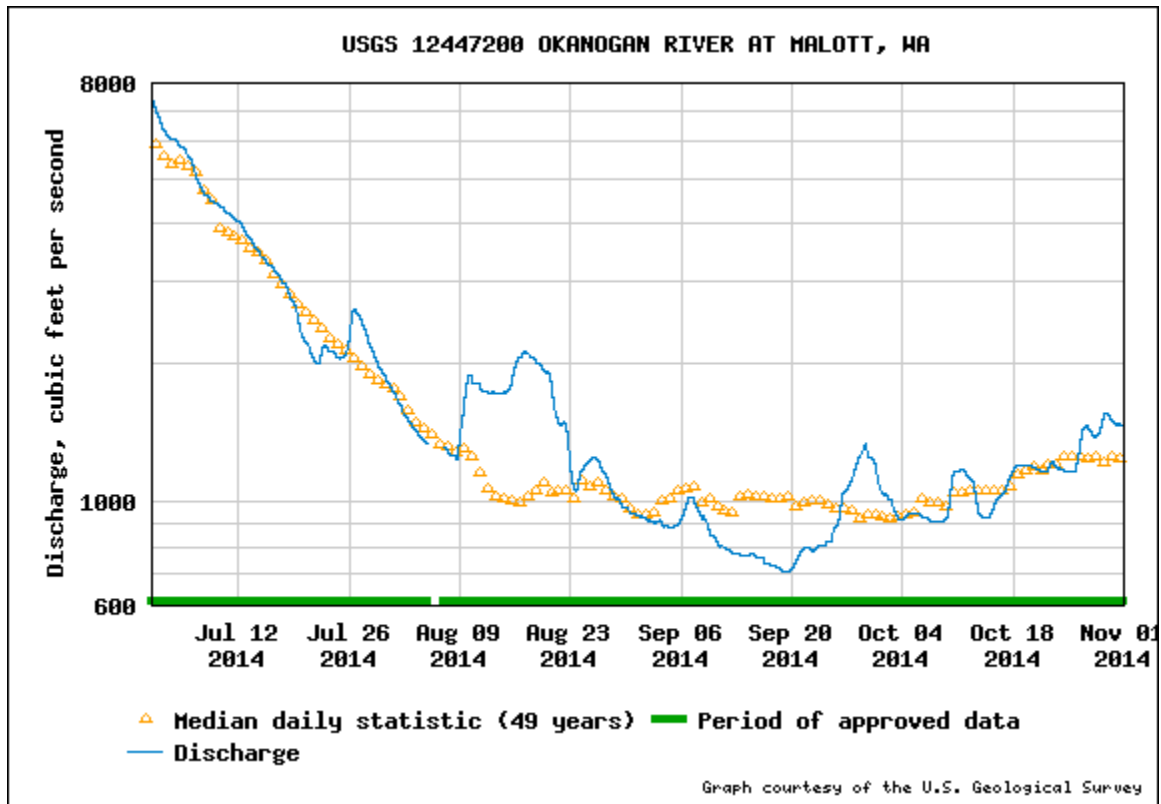
Figure 3. Discharge of the Okanogan River between July 1 and October 31, 2014. This figure was copied directly from the USGS website (<http://nwis.waterdata.usgs.gov/wa>).

The Okanogan River (at Malott) discharge was around the norm in 2014 and dropped to 2,000 cfs on July 28, 2014. Staff were able to safely enter the river and begin installation on August 4 when discharge was 1,350 cfs (Figure 3). Discharge continued to drop rapidly throughout the installation period until August 9 when it increased approximately 700 cfs over a two week period, presumably due to water management releases from Lake Okanogan designed to improve pre-spawn holding conditions for Sockeye in Lake Osoyoos. Discharge levels stayed below 1,200 cfs for the rest of the season.

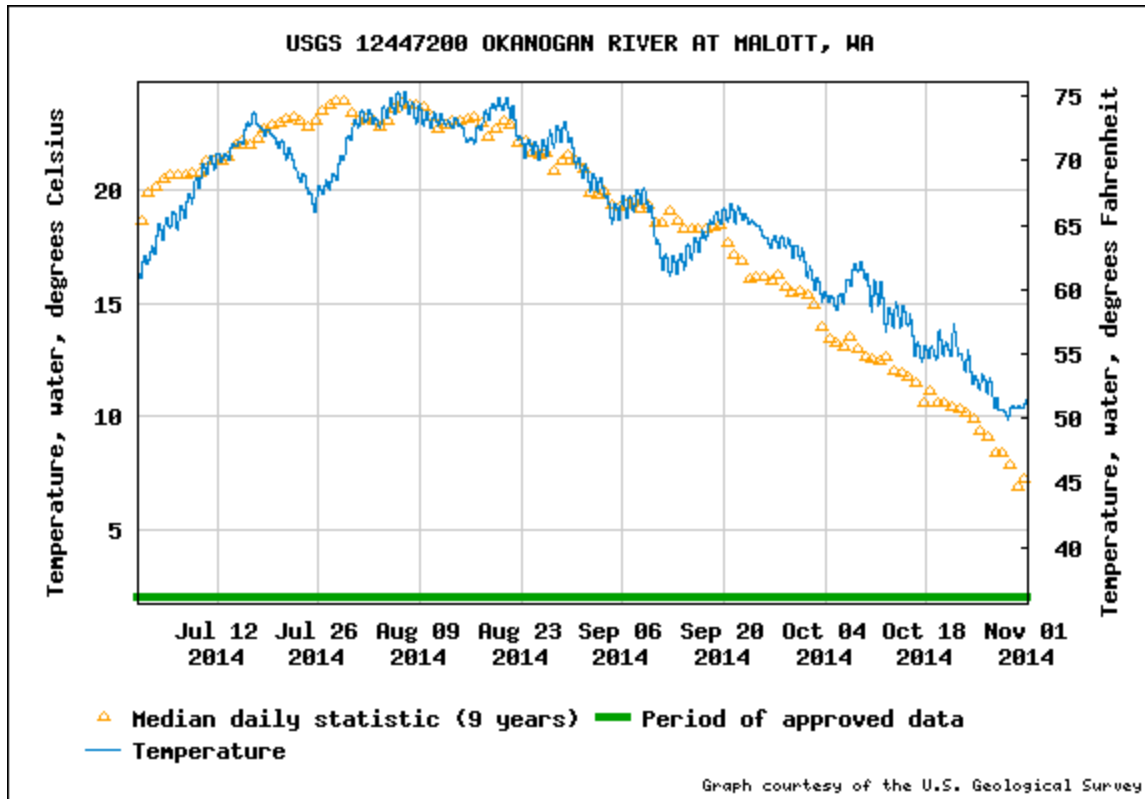
Figure 4. Temperature of the Okanogan River between July 1 and October 31, 2014. This figure was copied directly from the USGS website (<http://nwis.waterdata.usgs.gov/wa>).

Migration of Sockeye and summer Chinook is generally affected by a thermal barrier that is caused by warm water temperatures ($\geq 22^\circ \text{C}$) in the lower Okanogan River. The thermal barrier is dynamic within and between years, but generally it sets up in mid-July and breaks down in late August. In some years, the Okanogan River will temporarily cool off due to a combination of interrelated weather factors including rainstorms, cool weather, cloud cover or wildfire smoke. This 'break' in the thermal barrier can allow a portion of the fish holding in the Columbia River to enter the Okanogan and migrate up to thermal refuge in the Similkameen River or Lake Osoyoos. In 2014, temperatures were similar to, though often slightly higher than the median daily temperatures from the last 9 years (Figure 4). Temperature surpassed 22.5°C on July 15 when flow was 3,260 cfs. Temperatures stayed above 22.5°C until July 19 but then increased above 22.5°C again on July 30. Temperatures stayed above 22.5°C for a three week period. A steady decrease in

temperatures from a high of 24.0°C to a low 21.3 °C occurred from August 20 to 25. On August 29 temperatures stayed below 22.5 °C for the rest of the season.

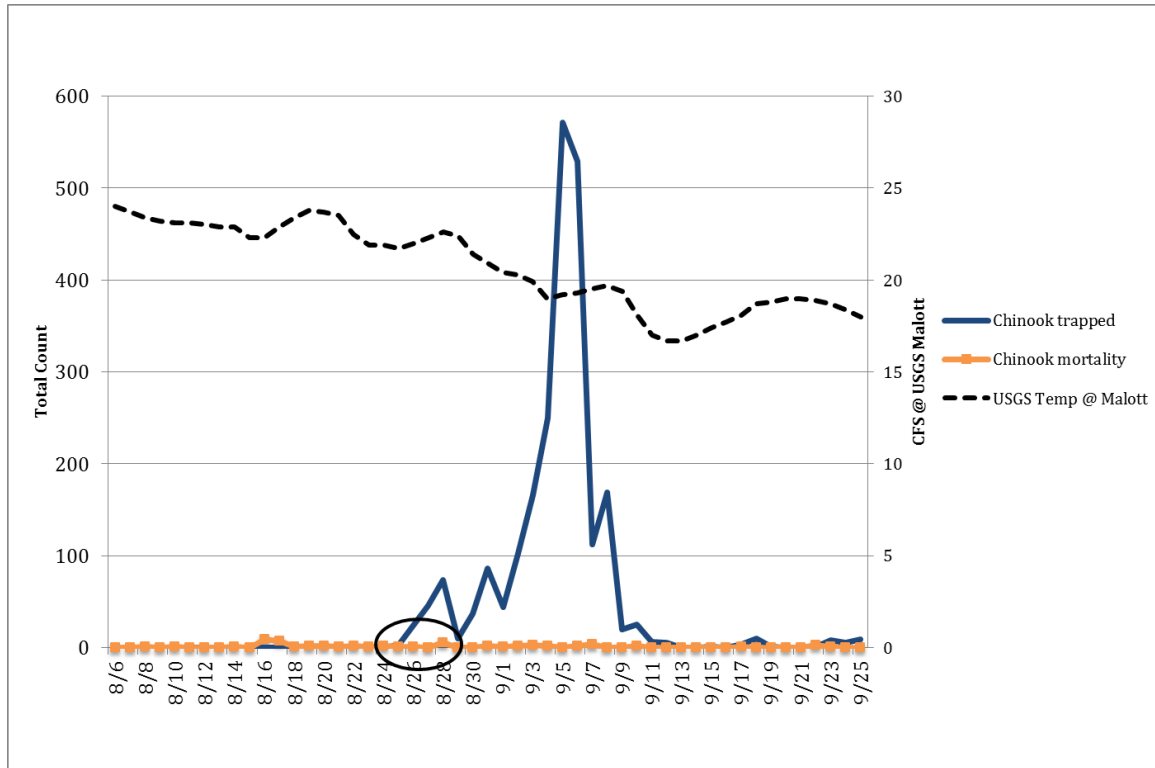
Figure 5. Total number of Chinook trapped and total number of Chinook carcasses collect off the weir panels. There was no drastic increase in Chinook carcasses at the weir after Chinook were encountered in the trap. This is indicated by the circle.

Although the number (202) of dead fish at the weir seems high, the reality was that dead 'wash ups' were not a good indicator of weir effects. A fish kill upstream that had nothing to do with the weir could cause many fish to wash up on the upstream side of the weir. Conversely, any adverse effects of the weir would not have been detected if fish carcasses were stranded on shore or taken by scavengers before washing up on the weir. However, behavioral observations and the lack of fish impinged between pickets (head upstream) were good indicators that this weir configuration and picket spacing were not a major cause of direct mortality. No data were collected to assess indirect mortality.

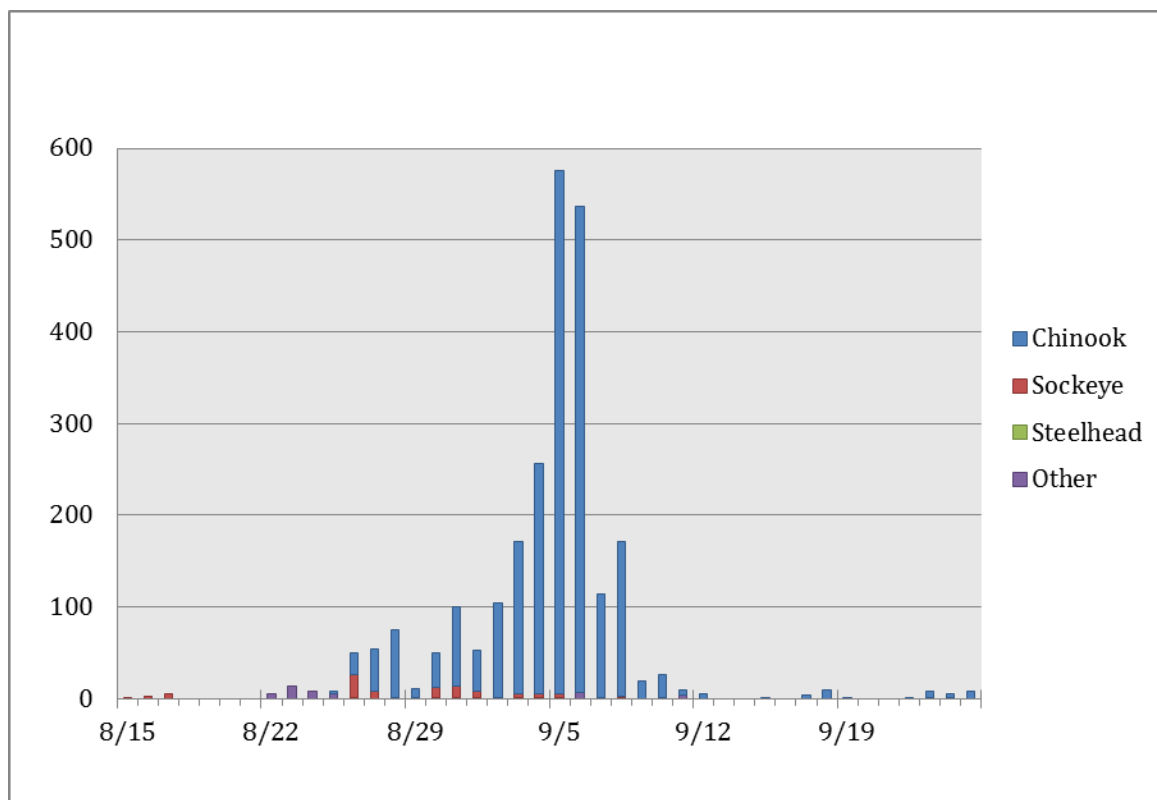
Figure 6. Total number of fish trapped at the Okanogan weir in 2014.

Trapping operations were conducted from August 15 to September 25 when river temperature was ≤ 22.5 °C . The total fish trapped at the weir in 2014 was 2477 with 94% of them being Chinook Salmon (Figure 6). Most of the Chinook trapped were released back into the river (Figure 7). Seventy-six hatchery Chinook were transported to the hatchery and held in the broodstock ponds concurrently with the fish taken for broodstock from the purse seine. None of the weir collected fish died at the hatchery as of the first spawn in early October.

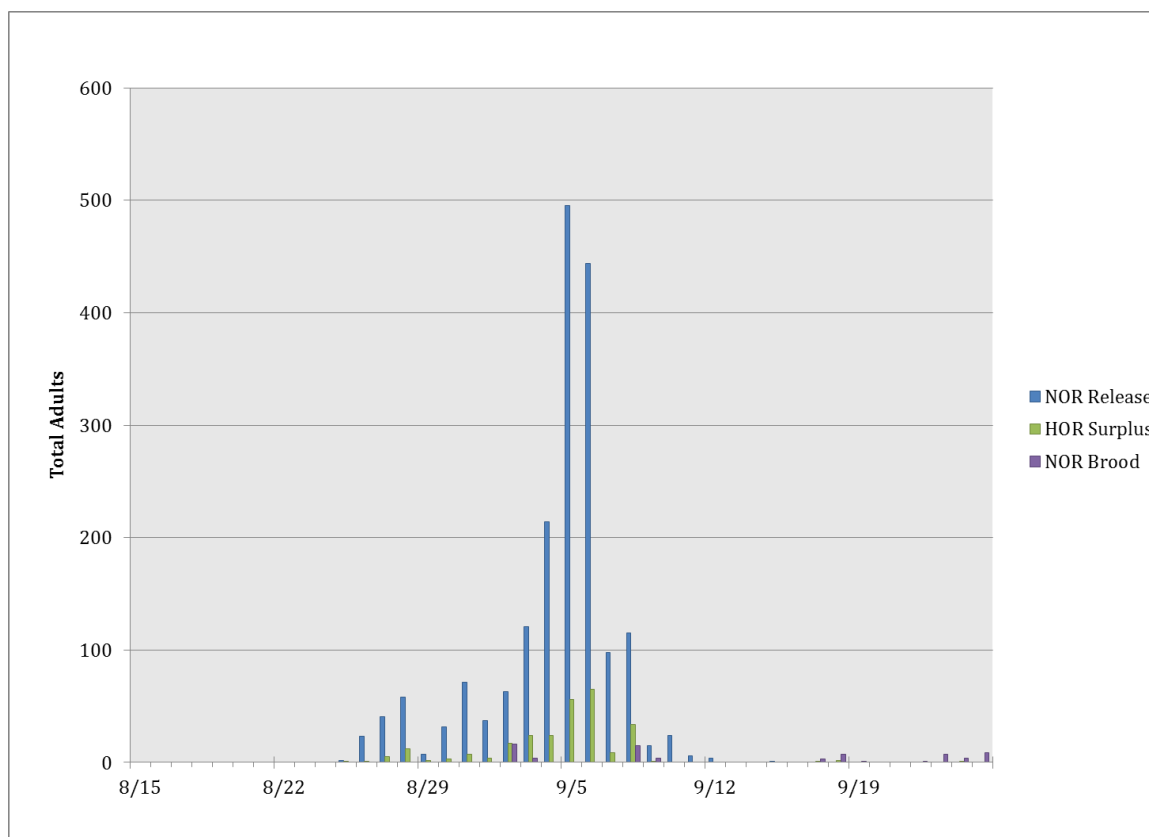
Figure 7. Final destination of Chinook adults captured in the weir trap during trapping operations in 2014.
