The Chief Joseph Hatchery Program

Okanogan River Adult Fish Pilot Weir

2015 Summary of Methods & Results

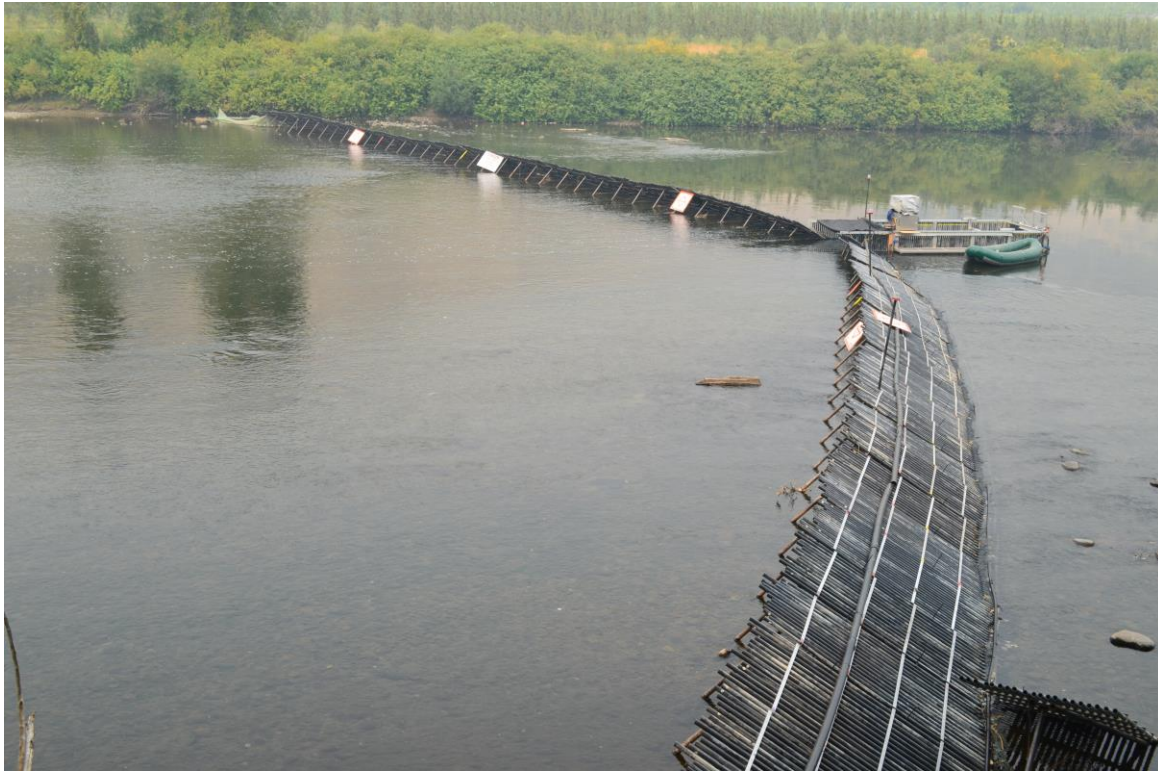
Figure 1. Lower Okanogan adult fish pilot weir, 2015. Photo taken in late August, one week after start of the Okanogan Complex wildfire.

The lower Okanogan fish weir was installed approximately 1.5 km downstream of Malott, WA (48°16'21.54 N; 119°43'31.98 W) in approximately the same location as previous years. Weir installation began on July 15th at a river flow of 1,250 cfs and was complete with the underwater video system on July 23rd. An aluminum trap was installed near the center of the channel at the upstream end of the deep pool in the thalweg of the channel. The trap was 3 m wide, 6 m long and 3 m high (Figure 1). The wings of the weir stretched out from either side of the trap towards the river banks, angling downstream in a slight V configuration. The wings consisted of steel tripods with aluminum rails that supported the 3 m long Acrylonitrile butadiene styrene (ABS) pickets. Each panel was zip-tied to the adjacent panel for strength and stability. Sand bags were placed between panels when needed to fill gaps that exceeded the target picket spacing. Picket spacing ranged from 2.5 to 7.6 cm (1 to 3 inch) in 1.2 cm (half-inch) increments (Figure 2). Pickets were manually forced into the river substrate upon deployment and then as needed to prevent fish passage under the weir.

The river-right wing consisted entirely of 2.5 cm picket spacing. A 3 m gap between the last panel and the right shoreline remained to allow for portage of small vessels around the weir. This was a very shallow gravelly area and under most flow conditions it did not appear to be a viable path for adult salmon passage. However, a block net was set up from the last panel to the river-right shore to limit escapement via this route. The river left wing had variable picket spacing to accommodate non-Chinook fish passage through the pickets. The primary objective of the wider picket spacing was to allow Sockeye (*O. nerka*) to pass through the weir and reduce the number of Sockeye that would enter the trap. River left was selected for this spacing to better accommodate observation/data collection regarding successful passage of smaller fish through the panels. In past years CCT has observed jack and even adult Chinook passing through the 7.6 cm picket spacing panels. To reduce the escapement of smaller hatchery Chinook, CCT wanted to partially block the 7.6 cm panels once the majority of sockeye had passed the weir. After consultation with the Technical Oversight Group (TOG), aluminum grating was placed on the 7.6 cm picket spacings on August 28th.
