The Chief Joseph Hatchery Program

Okanogan River Adult Fish Pilot Weir

2016 Summary of Methods & Results

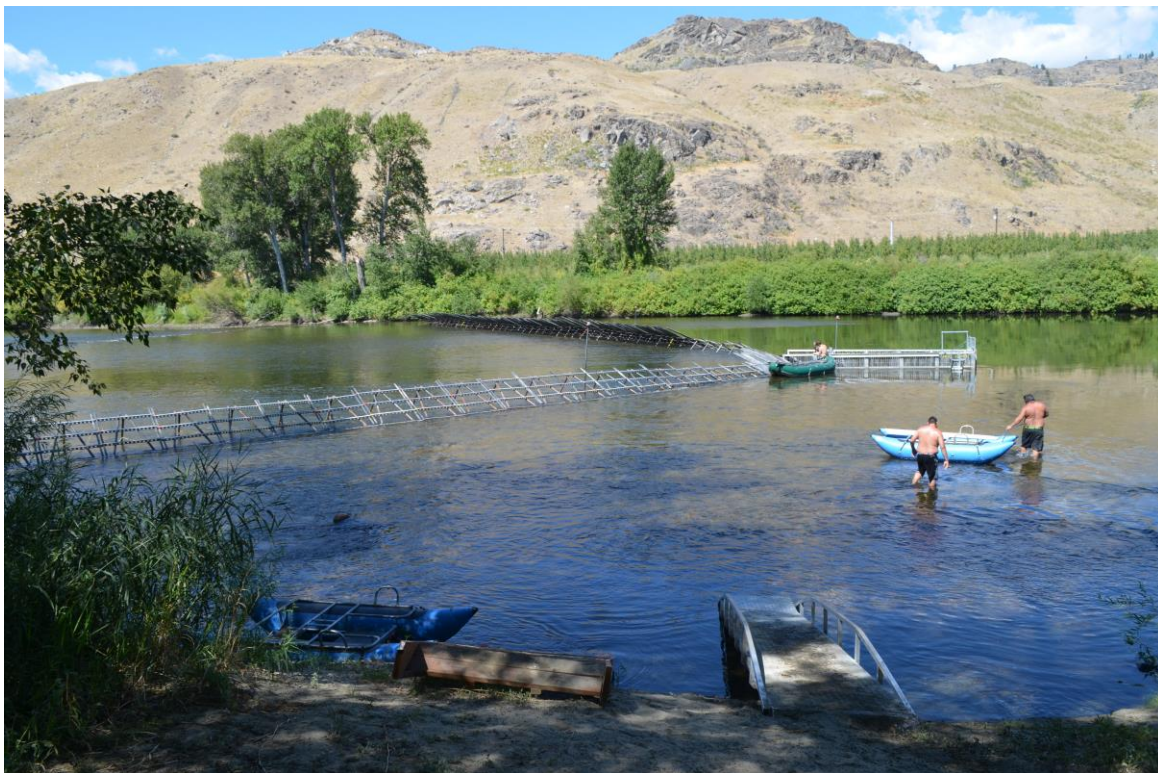
Figure 1. Lower Okanogan adult fish pilot weir, 2016. Photo taken in early August during deployment.

The lower Okanogan fish weir was installed approximately 1.5 km downstream of Malott, WA (48°16'21.54 N; 119°43'31.98 W) in approximately the same location as previous years. Weir installation began on August 8th at a river flow of 1,530 cfs and was complete with the underwater video system on August 17th. An aluminum trap was installed near the center of the channel at the upstream end of the deep pool in the thalweg of the channel. The trap was 3 m wide, 6 m long and 3 m high (Figure 1). The wings of the weir stretched out from either side of the trap towards the river banks, angling downstream in a slight V configuration. The wings consisted of steel tripods with aluminum rails that supported the 3 m long Acrylonitrile butadiene styrene (ABS) pickets. Each panel was zip-tied to the adjacent panel for strength and stability. Sand bags were placed between panels when needed to fill gaps that exceeded the target picket spacing. Picket spacing ranged from 2.5 to 6.4 cm (1 to 2.5 inch) in 1.2 cm (half-inch) increments (Figure 2). Pickets were manually forced into the river substrate upon deployment and then as needed to prevent fish passage under the weir.

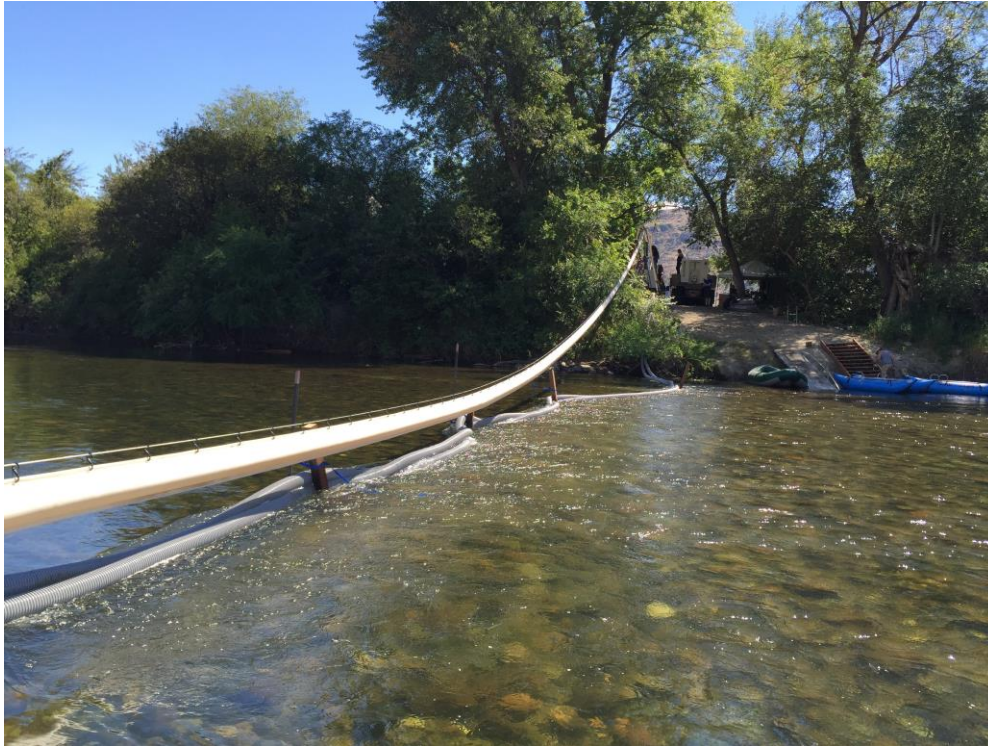
Figure 3. Whooshh™ fish transport system installed at the Okanogan weir. Photo taken from the gangway at the trap.

A negative pressure transport tube, known as a Whooshh™ fish transport system, was installed to assist CCT with broodstock collection at the Okanogan weir. The 49 m tube was connected to an accelerator at the upstream side of the trap and at a mobile trailer fitted with a decelerator, tower, tube reel, blower housing, and accelerator entrance and exit mounts. A diesel generator provided remote power to run the pump that generated power for the pneumatic portions of the system.

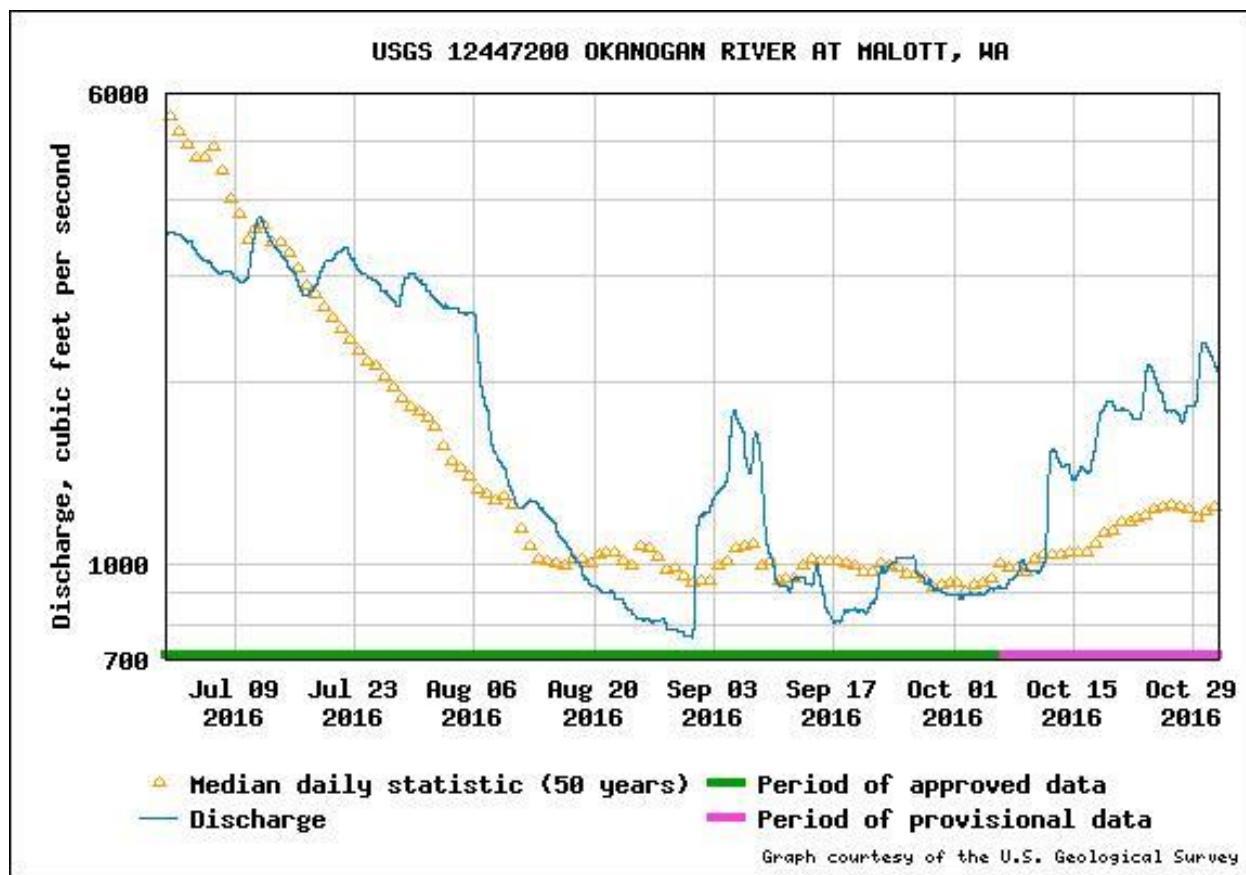
Figure 3. Discharge of the Okanogan River between July 1 and October 31, 2016. This figure was copied directly from the USGS website (<http://nwis.waterdata.usgs.gov/wa>).

The Okanogan River (at Malott) discharge was below normal in 2016 and was below 1,800 cfs for the trapping season. Staff were able to safely enter the river and begin installation on August 8 when discharge was 1,530 cfs (Figure 3). Discharge continued to drop throughout the installation period until August 31 when levels increased rapidly up to 1,760 cfs due to Okanogan water management objectives) before dropping again on September 6. After September 9, discharge stayed between 800-1,000 cfs for the rest of the season.

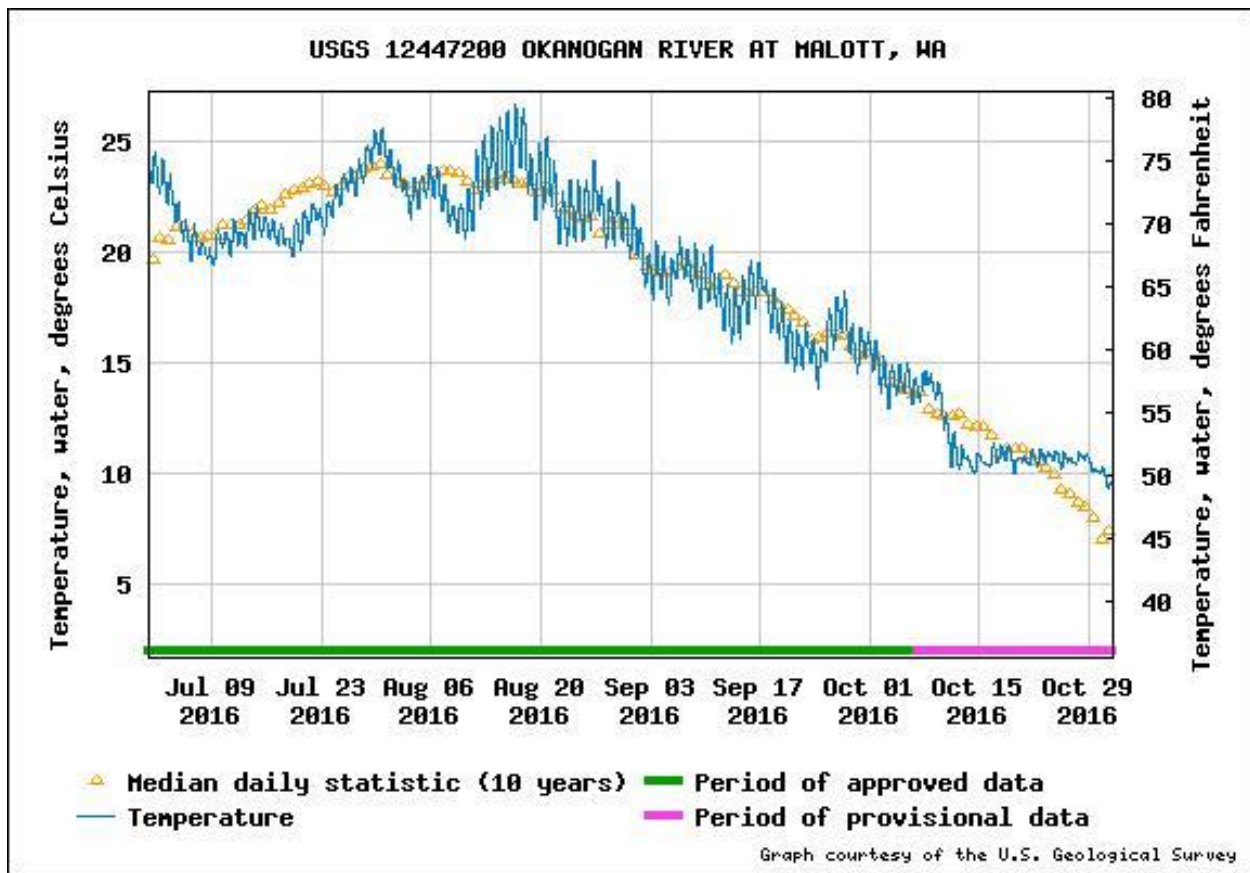
Figure 4. Temperature of the Okanogan River between July 1 and October 31, 2016. This figure was copied directly from the USGS website (<http://nwis.waterdata.usgs.gov/wa>).

Migration of Sockeye and summer Chinook is generally affected by a thermal barrier that is caused by warm water temperatures ($\geq 22^{\circ}\text{C}$) in the lower Okanogan River. The thermal barrier is dynamic within and between years, but generally it sets up in mid-July and breaks down in late August. In some years, the Okanogan River will temporarily cool off due to a combination of interrelated weather factors including rainstorms, cool weather, cloud cover or wildfire smoke. This 'break' in the thermal barrier can allow a portion of the fish holding in the Columbia River to enter the Okanogan and migrate up to thermal refuge in the Similkameen River or Lake Osoyoos. In 2016, temperatures were similar to, though occasionally higher than the median daily temperatures from the last 10 years (Figure 4). Temperature was above 22.5°C on July 1 when flow was 3,530 cfs. Temperatures stayed above 22.5°C until July 4, when they began to drop and stayed below 22.5°C until July 24. From July 24 to August 3 temperatures increased above 22.5°C . Temperature varied again between 26.6°C and 20.6°C from August 3-30. After August 30 temperatures stayed below 22.5°C for the rest of the season.

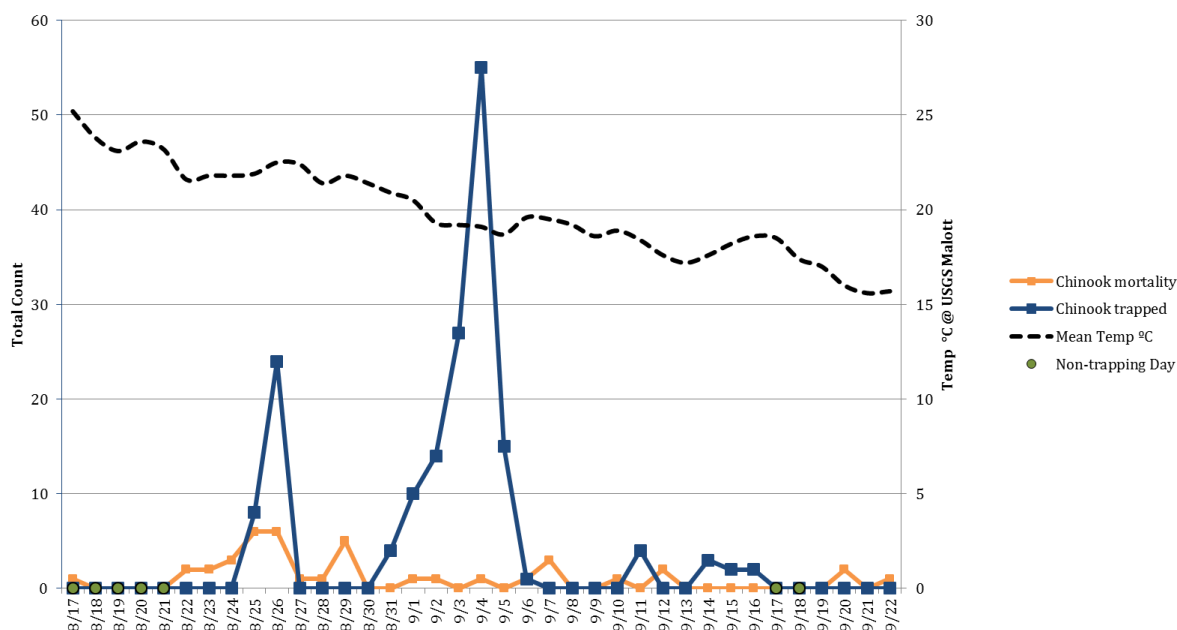
Figure 5. Total number of Chinook trapped and total number of Chinook carcasses collected off the weir panels. The majority of the Chinook carcasses occurred a week before most Chinook were encountered in the trap.

None of the water quality parameters monitored were at a level that would cause concern regarding an environmental effect of the weir on water quality. The number (54) of dead fish at the weir was lower in 2016 than previous years. Mortality was highest a week before the peak trapping period, indicating that trap operation and handling were not the cause of mortality. The behavioral observations and lack of fish impinged between pickets (head upstream) were good indicators that this weir configuration and picket spacing were not a major cause of direct mortality. In an attempt to assess immediate indirect mortality, we marked and released 117 adult natural-origin Chinook at the weir trap. Two of them were collected as mortalities at the weir, which is less than 1.7% of all trapped, marked and released fish. Additionally 4 of them were collected as carcasses on the spawning grounds (3.4%) and 2 were collected as broodstock for the integrated program (1.7%). We recommend additional mark-recapture studies to continue to assess indirect mortality at the weir in future years.

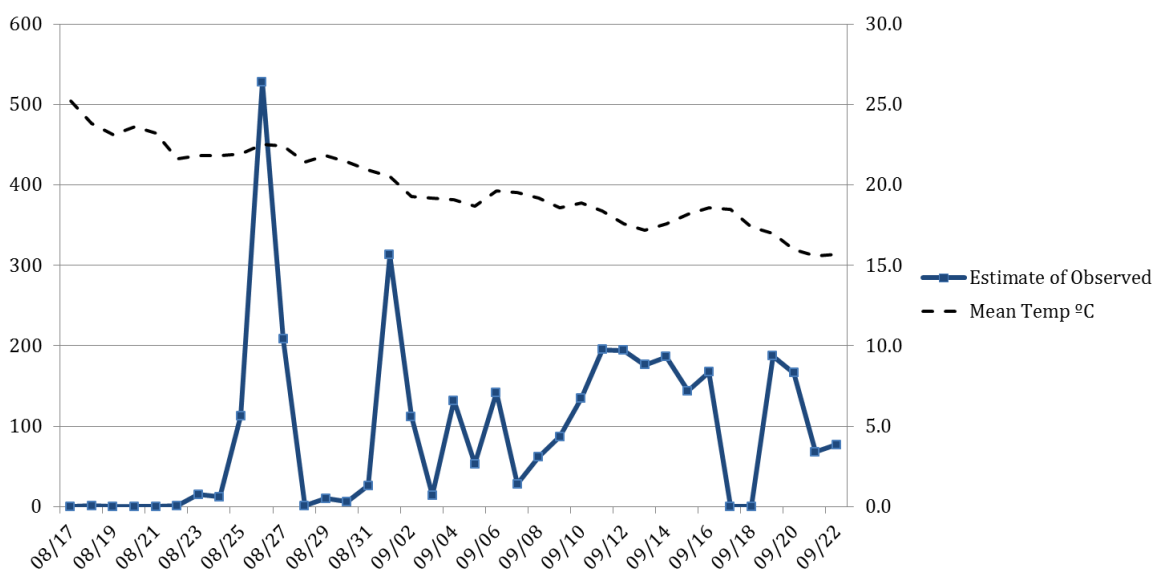
Figure 6. Estimate of Chinook observed from the bank at the lower pool, 0.8 km downstream of the weir.

Tower observations showed that most fish were equally distributed across the river, milling in the river right, left and center sections (looking downstream). Estimates were highest during the last week of August and the first week of September when river temperatures were below 22.5 °C. Bank observations showed that the number fish observed holding in the lower pool, 0.8 km below the weir, was highest about four days after the thermal barrier breakdown (Figure 6). Trapping operations were conducted after August 22nd when river temperature was ≤ 22.5 °C. The total fish trapped at the weir in 2016 was 190 with 89% of them being Chinook Salmon (Figure 7). Seventy percent of the Chinook trapped were released back into the river (Figure 8). Two steelhead were trapped between 9/10-9/20 and released in good condition within 30 minutes of observation. The TOG was notified when steelhead were trapped, including the total number, origin and condition after release. To reduce handling of fish, trap attendants opened the gate of the crowder and the upstream gate of the trap to allow for complete passage. Fish that were passed upstream were classified as having a vigorous condition, swimming away unharmed.

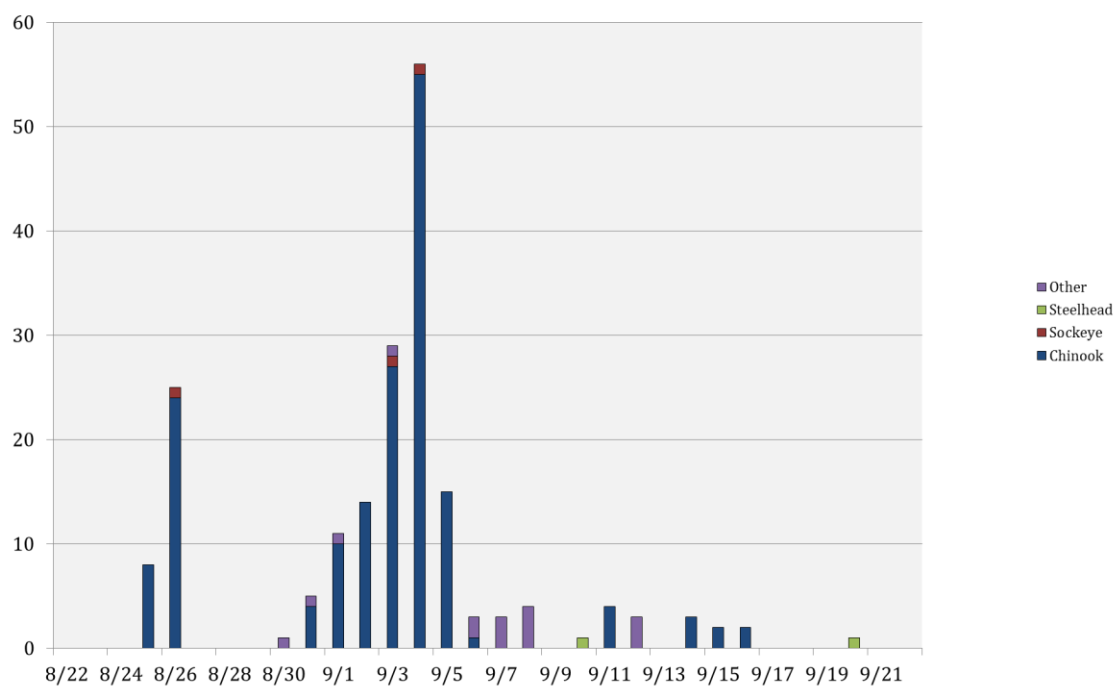
Figure 7. Total number of fish trapped at the Okanogan weir in 2016.

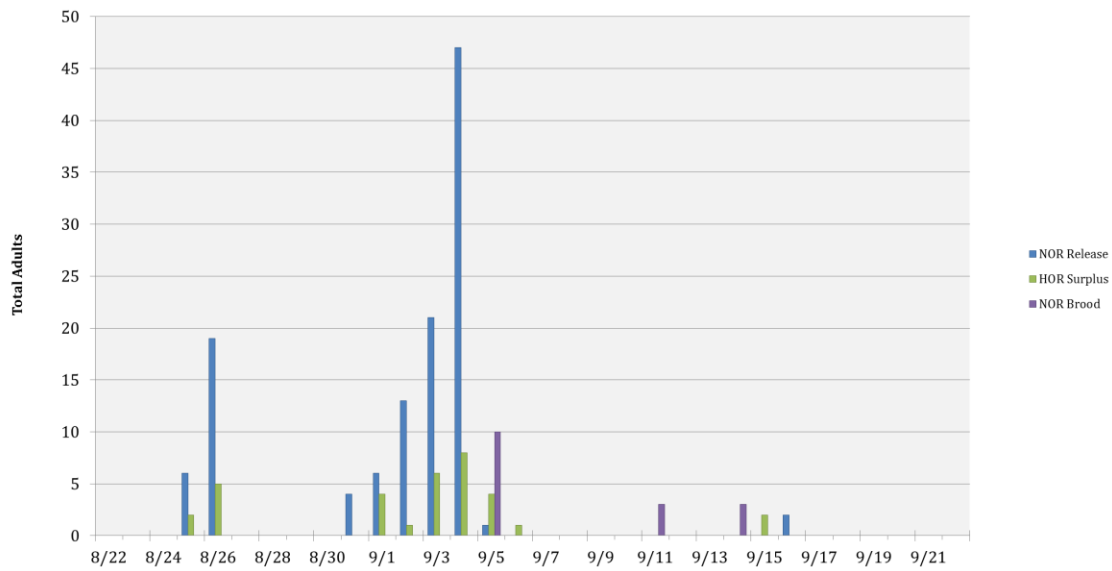
Figure 8. Final destination of Chinook adults captured in the weir trap during trapping operations in 2016.
