The Chief Joseph Hatchery Program

Okanogan River Adult Fish Pilot Weir

2018 Summary of Methods & Results

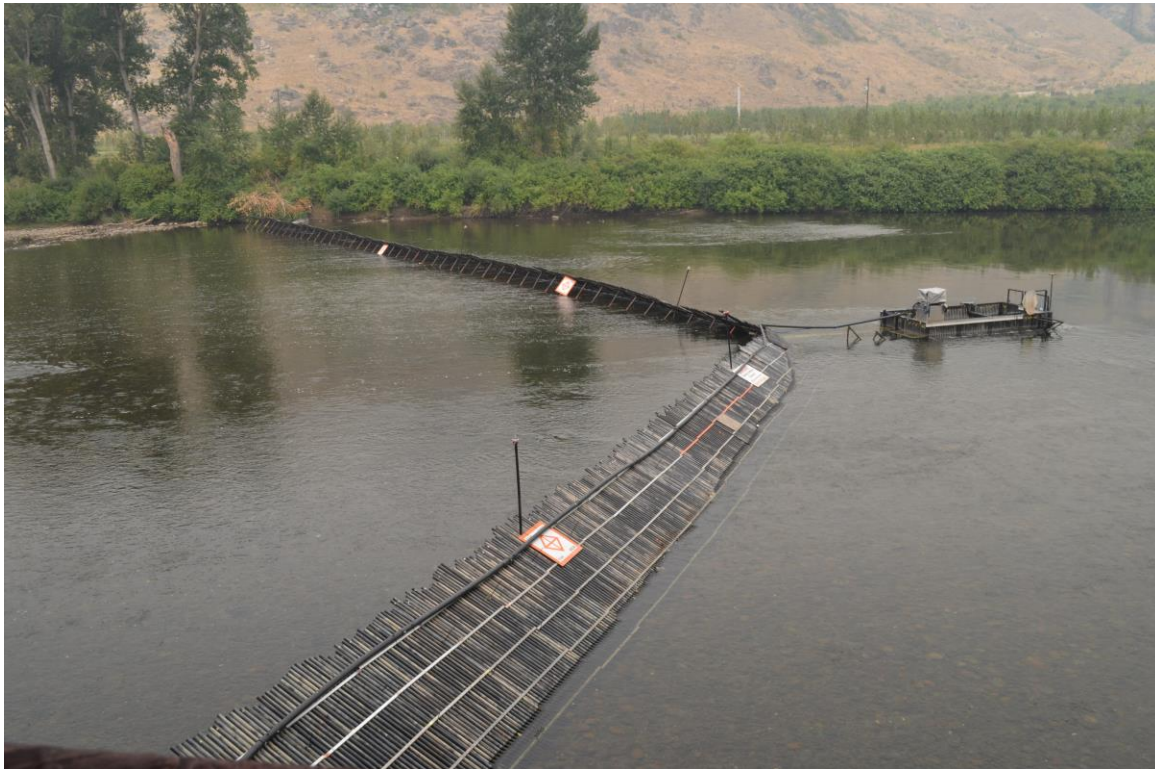
Figure 1. Lower Okanogan adult fish pilot weir, 2018. Photo taken in mid- August just after deployment.

The lower Okanogan fish weir was installed approximately 1.5 km downstream of Malott, WA (48°16’21.54 N; 119°43’31.98 W) in approximately the same location as previous years. Weir installation began on August 6th at a river flow of 1,230 cfs. and was completed with the underwater video system on August 10th. An aluminum trap was installed near the center of the channel at the downstream end of the deep pool in the thalweg of the channel. The trap was 3 m wide, 6 m long and 3 m high (Figure 1). A fifteen foot aluminum accelerator chute was installed at the downstream trap gate. The wings of the weir stretched out from either side of the chute towards the river banks, angling downstream in a slight V configuration. The wings consisted of steel tripods with aluminum rails that supported the 3 m long Acrylonitrile butadiene styrene (ABS) pickets. Each panel was zip-tied to the adjacent panel for strength and stability. Sand bags were placed between panels when needed to fill gaps that exceeded the target picket spacing. Picket spacing ranged from 2.5 to 5.1 cm. (1 to 2 inch) in 1.2 cm. (half-inch) increments (Figure 2). Pickets were manually forced into the river substrate upon deployment and then as needed to prevent fish passage under the weir.
