2022 UPPER COLUMBIA AND SANPOIL HABITAT RESTORATION PLAN

Prepared for:
Confederated Tribes of the Colville Reservation

Prepared by:
Phil Roni, Ph.D., Kai Ross, Ph.D., and Raymond K. Timm, Ph.D.,

Revised Final Report April 11, 2022

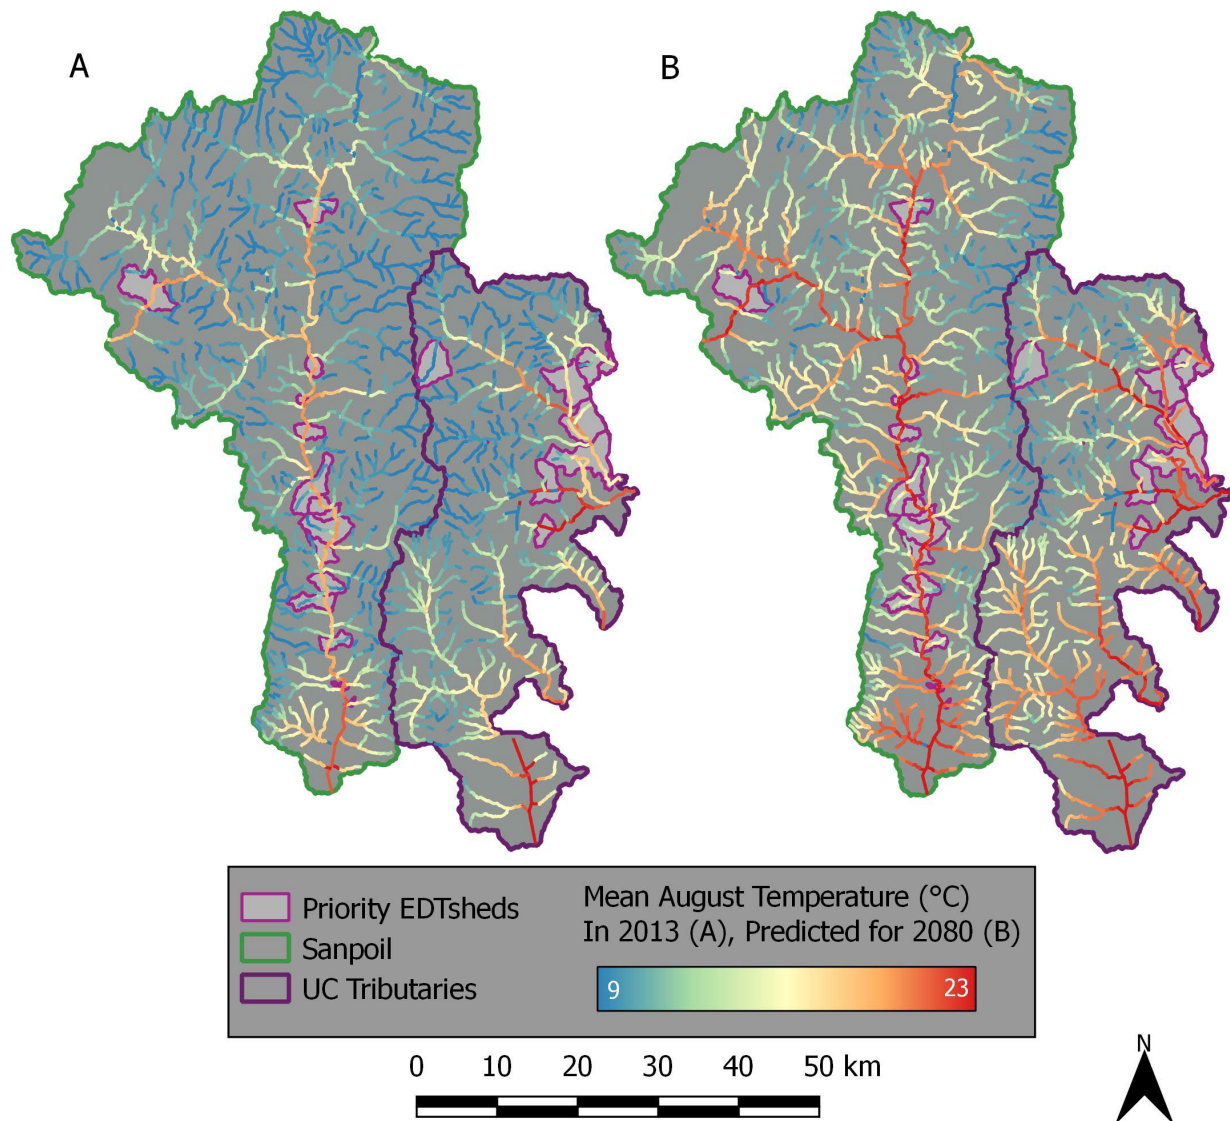
Figure 5. NorWeST modeled daily average August stream temperatures for Upper Columbia and Sanpoil subbasins under current (A) and 2080 future climate scenarios (B). Temperatures range from 9 to 23 degrees Celsius.

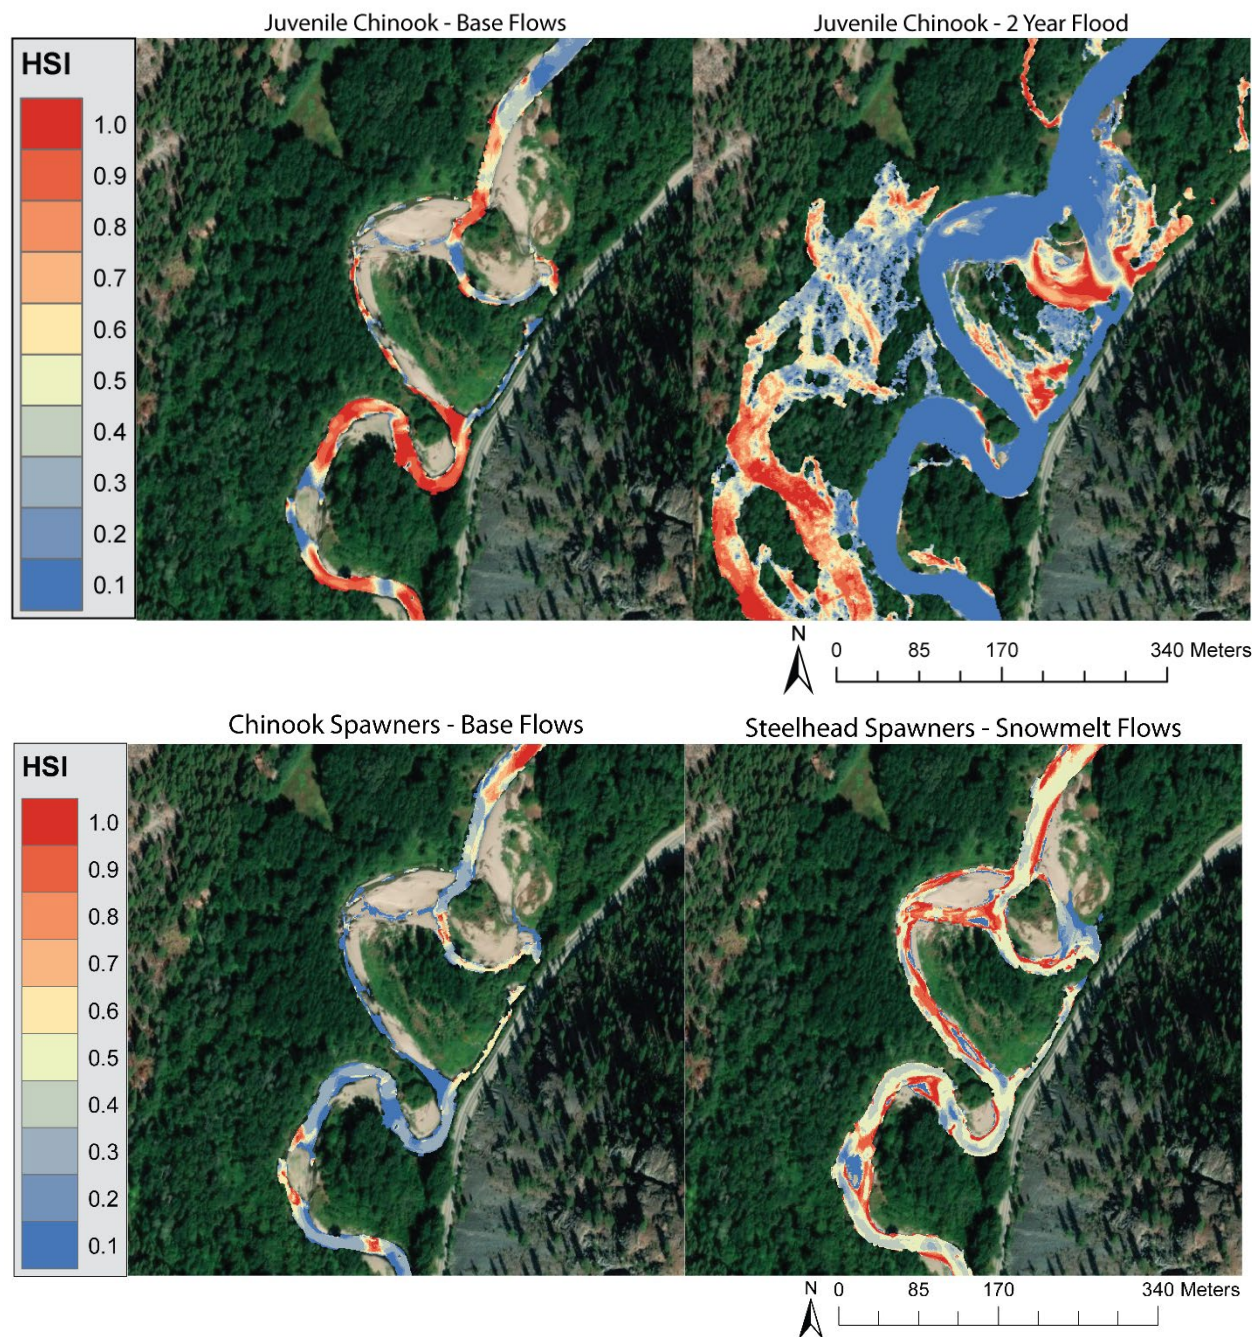
Figure 9. Example of HSI outputs and maps for different flows, species, and life stages for the Entiat River before restoration (Roni et al. 2020b).

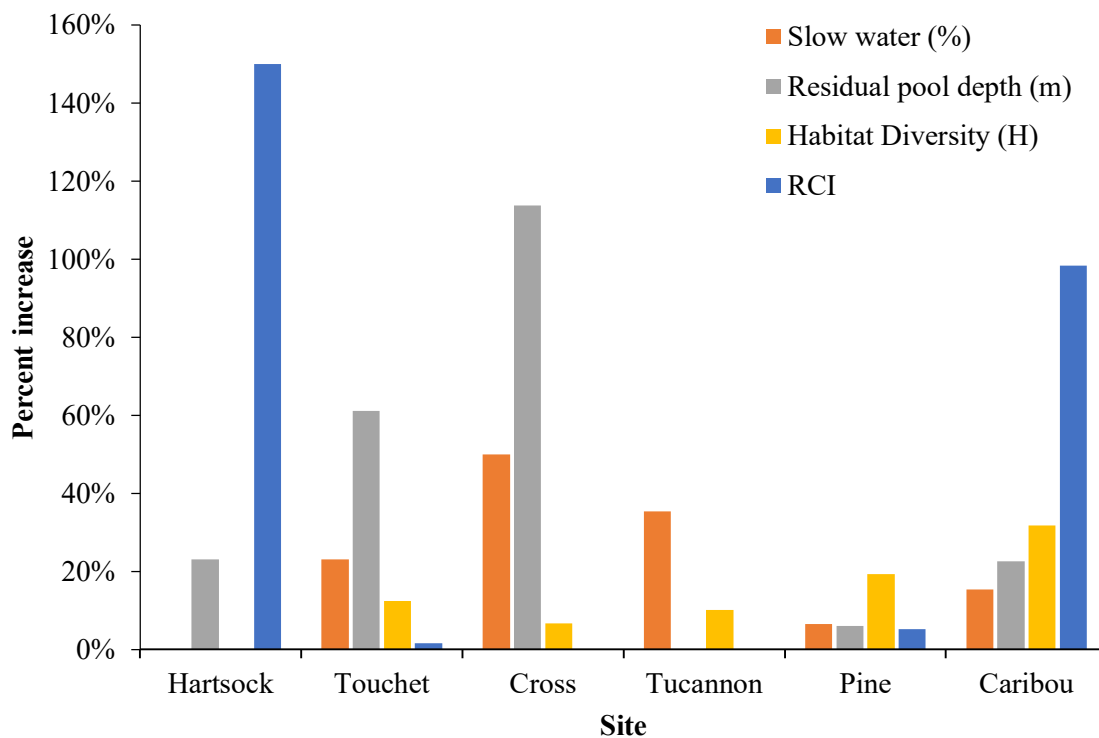
Figure 12. Example of simple graphical presentation of change of a sub-set of monitoring metrics for six floodplain restoration projects before and after restoration.

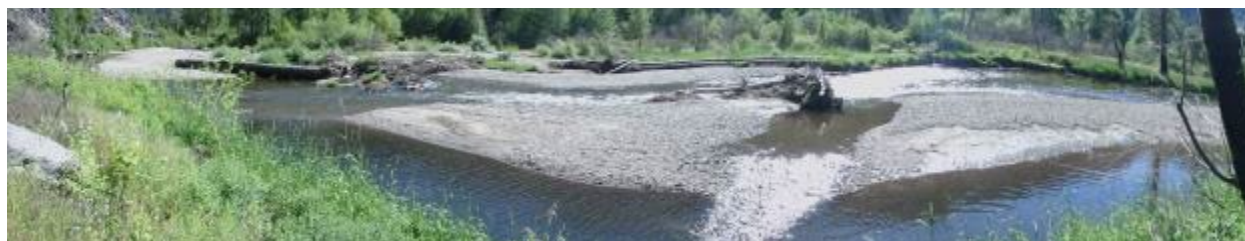
Figure B-3. Representative panoramic photo of Sanpoil 4B reach showing multi-thread channel, LWD and gravel stored in the channel resulting from large floods (discharge estimates exceed 12,500 cfs) during April 2017 rain-on-snow event. Discharge during this photo was approximately 125 cfs.

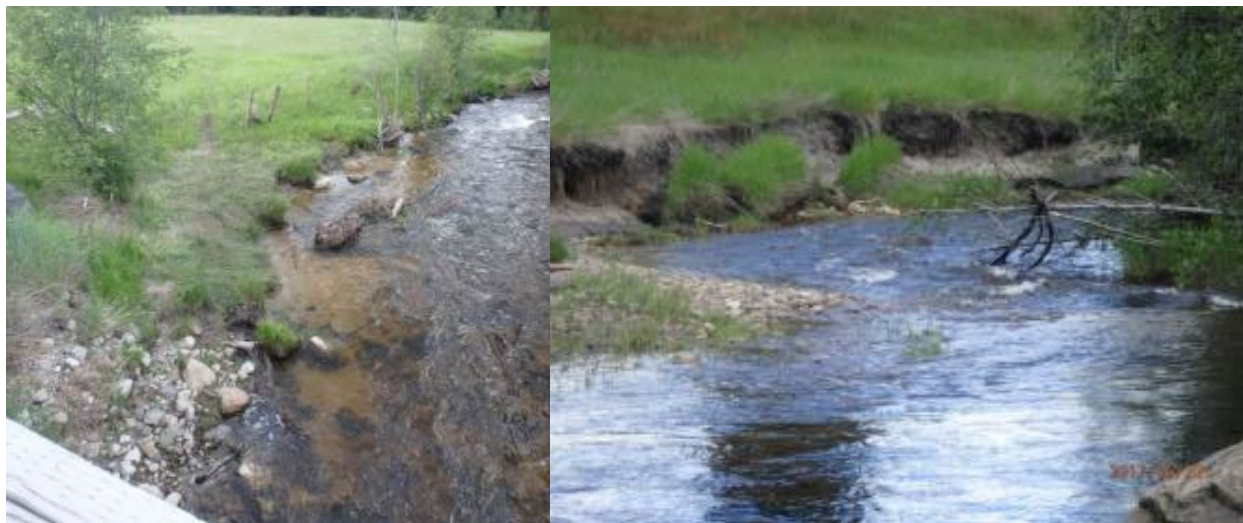
Figure B-5. Classic examples of grazing impacts at the top of Lost 6 reach. Left panel shows a failing fence and path where cattle access the stream. Right panel shows an over steepened, failing bank.

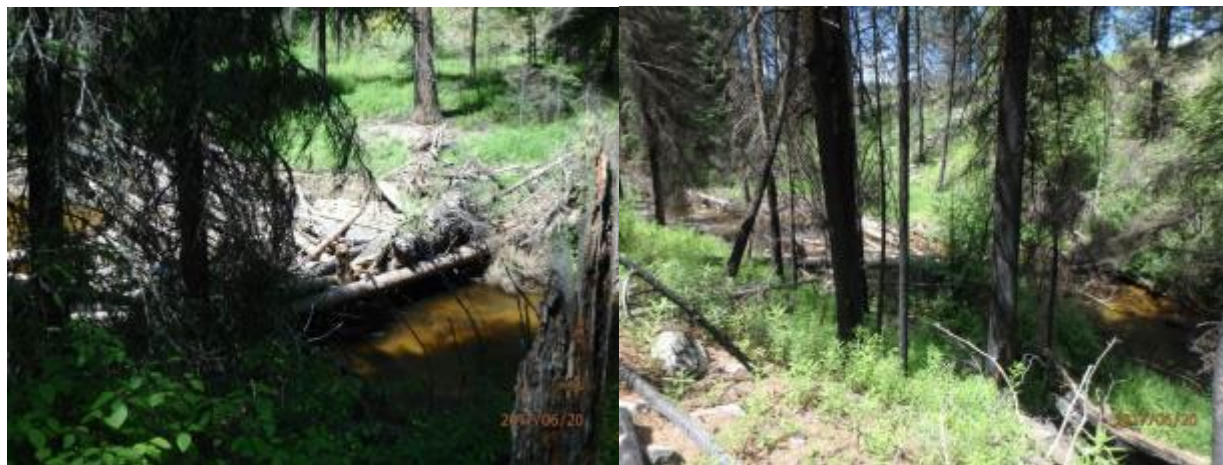
Figure B-6. Channel spanning log jam (left panel) and reach with high natural LWD loads in Lost 6 reach. This reach should be used to determine restoration targets for the rest of the reach, and other similar sized streams in the study.

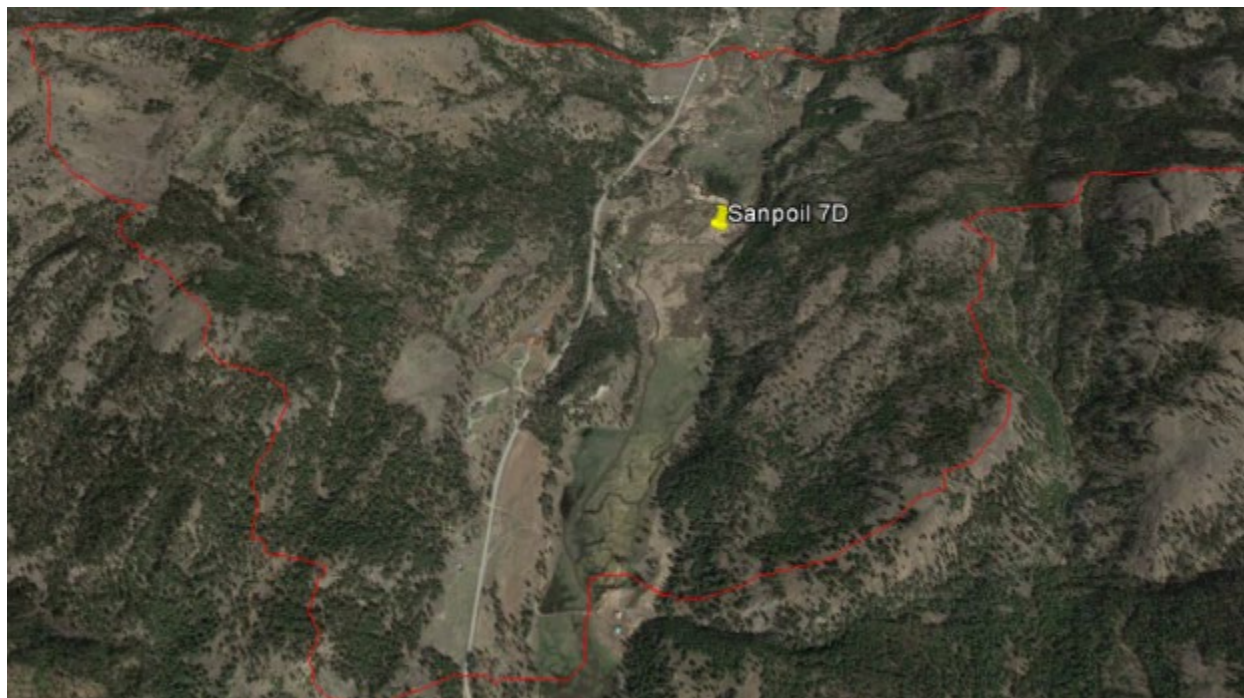
Reach Name: Sanpoil 7D

Figure B-7. Overview of Sanpoil 7D reach. This reach is almost entirely in agricultural production. There is virtually no shrub or tree riparian cover. Red lines indicate the boundary of upslope lands draining to the reach. Note the existence of historic channels on the east side of main channel that would provide excellent restoration opportunities.

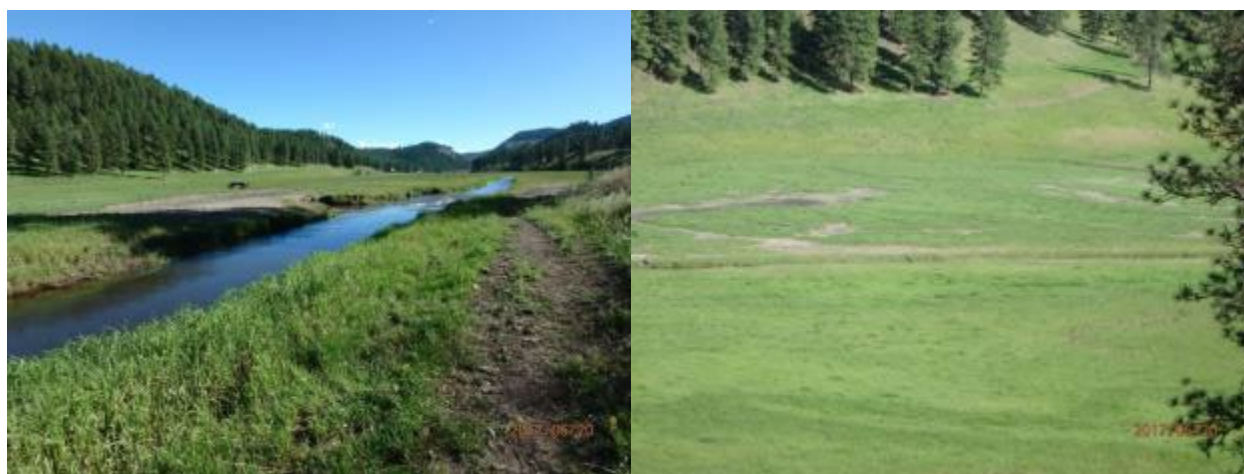
Figure B-8. Sanpoil 7D reach representative section, looking downstream to the bottom of the reach (left panel). Note the complete lack of woody riparian vegetation, over steepened and collapsing banks, and straightened homogeneous channel form (right panel).

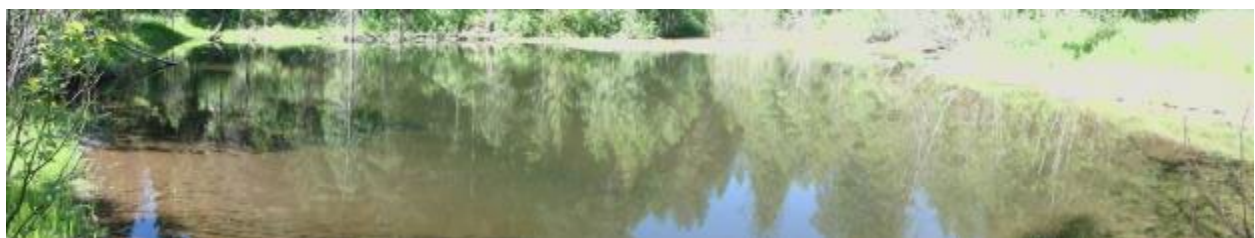
Figure B-10. Online pond impounded by a dam that is located along the left margin of the photo. The pond is approximately 35 m on a side. Very high quality fish and riparian habitat are located upstream.

Land ownership is mixed in this area. Ownership and landowner willingness needs to be verified. Also, an engineering study and plan will be needed to quantify and dispose of fine sediments impounded behind the dam.

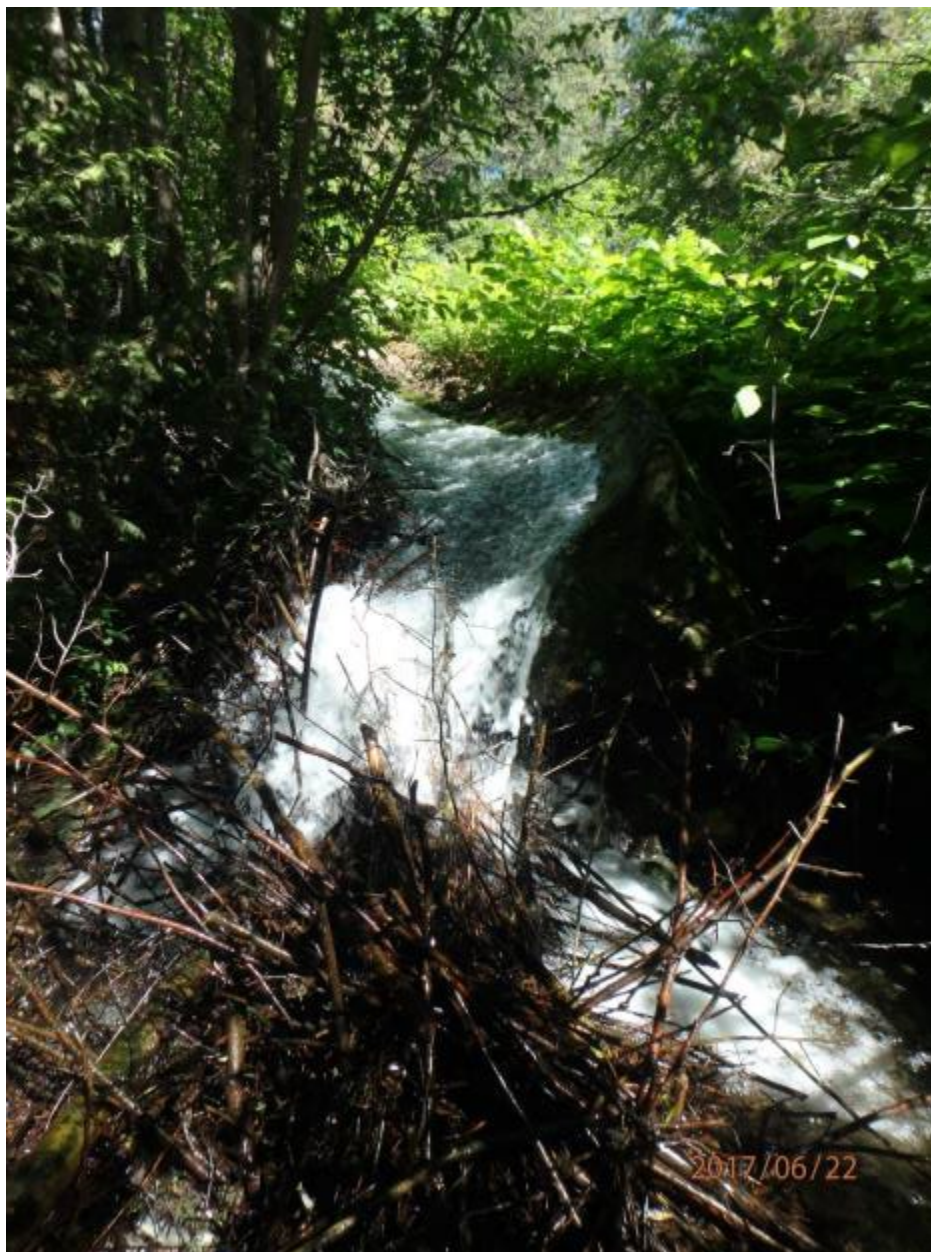
Figure B-11. Concrete overflow chute on the Cedar Creek dam. Overflow water drains from the pond surface and falls approximately 4 meters with a 1 m impassable drop to the stream bed at the bottom of the chute.

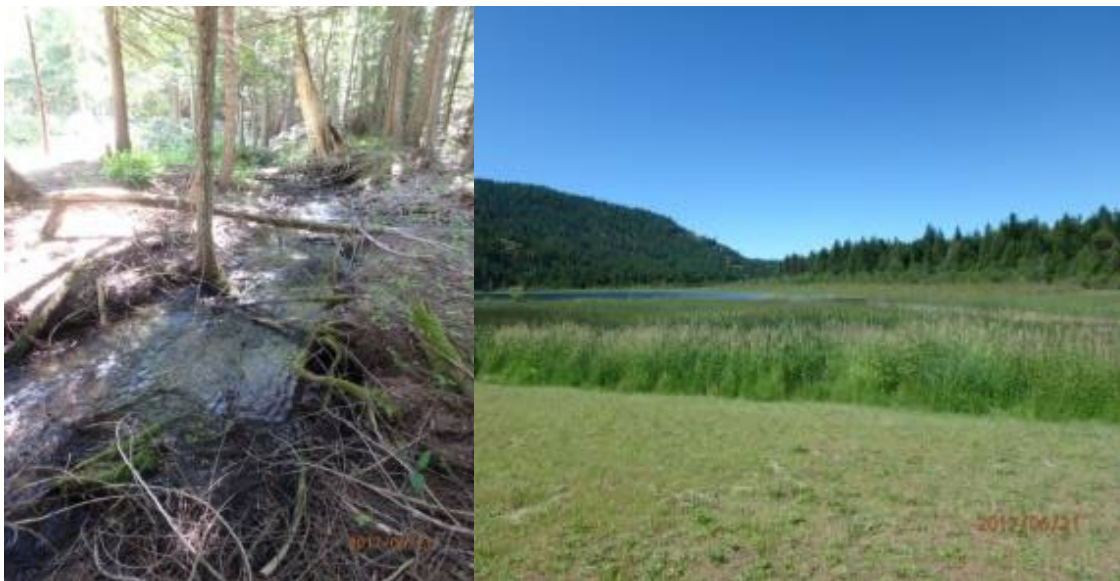
Figure B-13. Upper Cornstalk 5C reach drains through a cedar forest (left panel), and the lower portions drain through a wide valley wetland/lake ecosystem (right panel).

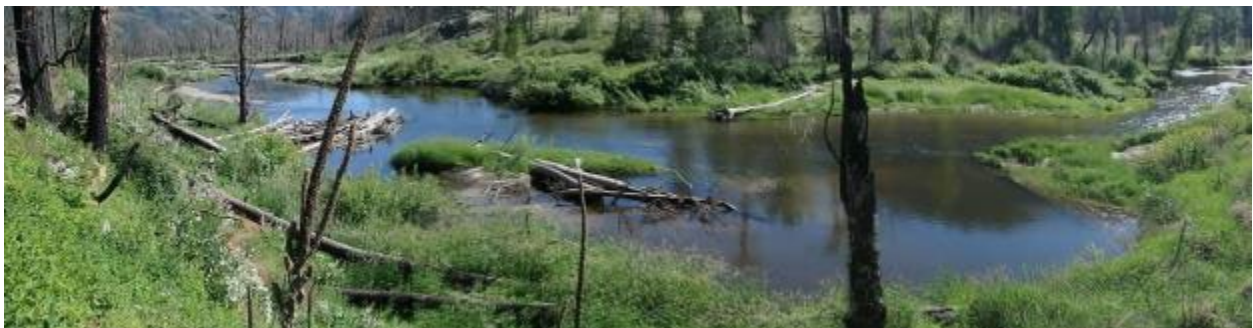
Figure B-15. Representative photo of Sanpoil 4A reach showing fire impacts to riparian forest, and the low gradient meandering stream. Note LWD in the channel here. Further downstream, there is relatively little LWD (see Figure B-16 below).

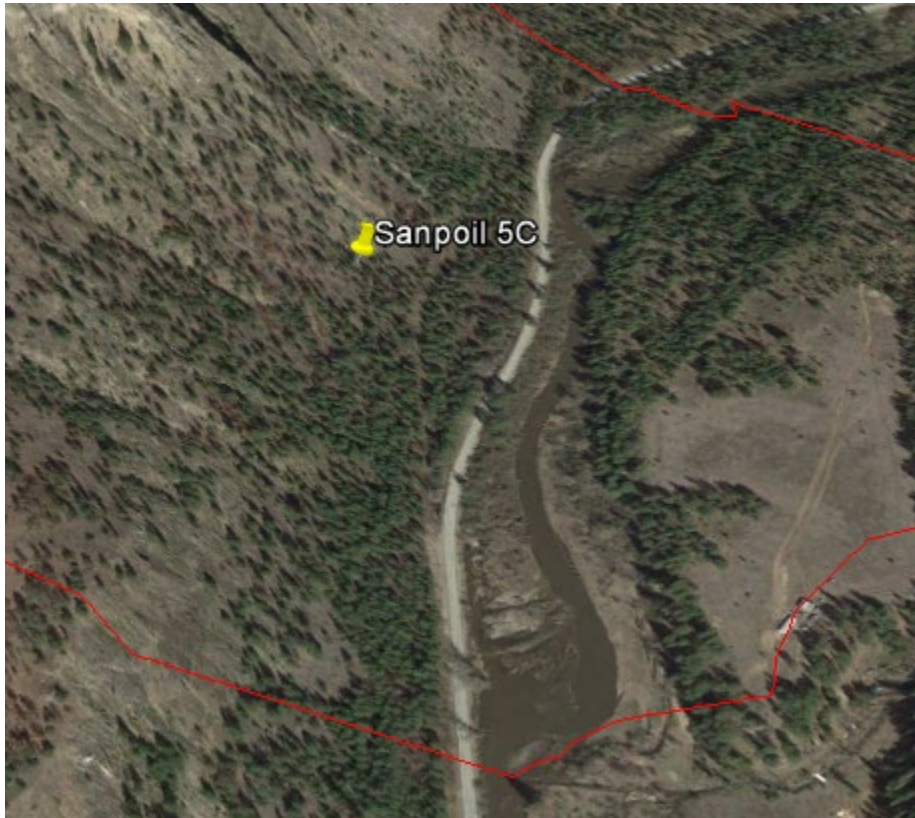
Reach Name: Sanpoil 5C

Figure B-17. Overview of Sanpoil 5C reach. This reach has changed dramatically due to the April 2017 floods relative to this 2016 photo. Red lines indicate the upslope area that drains to this reach.

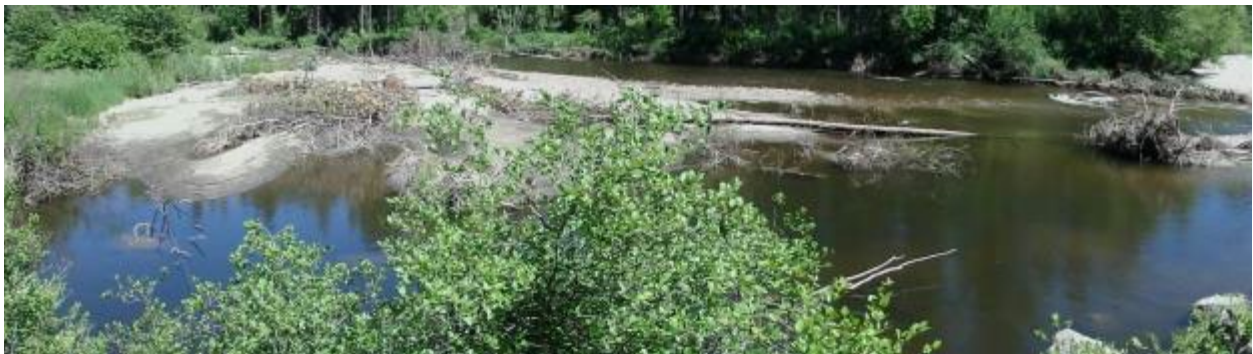
Figure B-18. Highly complex habitat including off channel habitat, gravel bars, pools, and LWD in the channel resulting from the April 2017 flood. This should represent target restoration conditions for other mainstem Sanpoil River reaches.

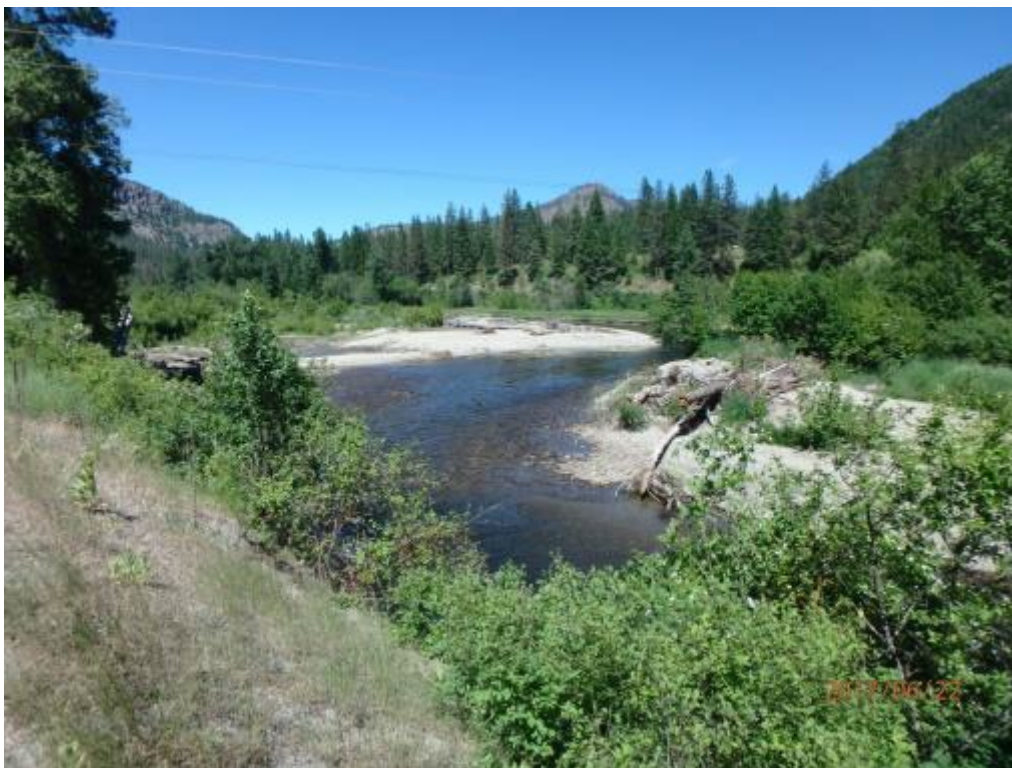
Figure B-19. Bottom end of Sanpoil 5C reach. Note LWD jams storing gravel on both banks. This habitat condition should be used to target restoration conditions in other reaches of the mainstem Sanpoil River.

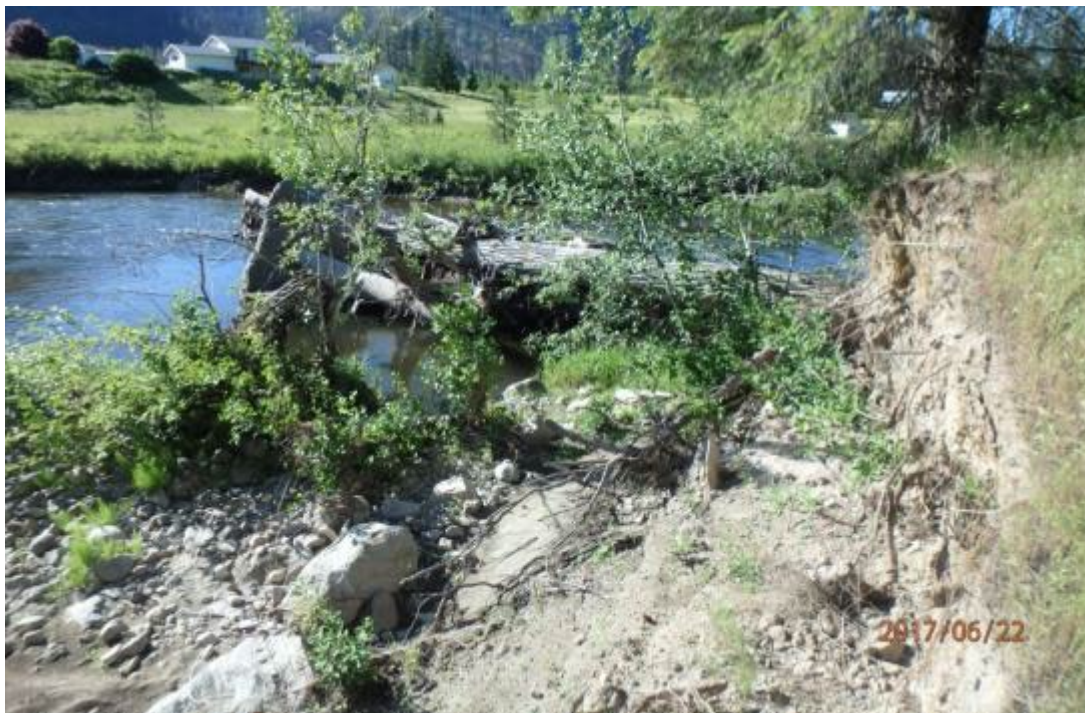
Figure B-21. Representative photo of habitat quality in Sanpoil 3D reach. Note single-thread channel with relative lack of riparian zone.

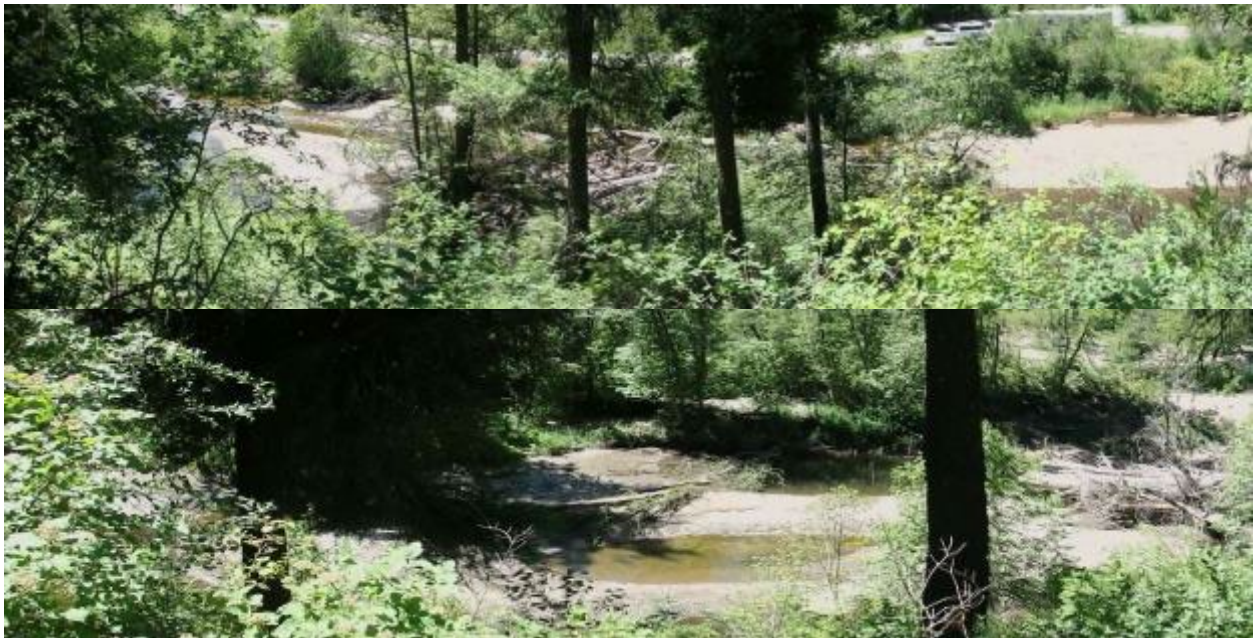
Figure B-23. Sanpoil 5E reach detail. Upper panel shows large jam in the center of the channel that engaged and created floodplain habitat (lower panel).

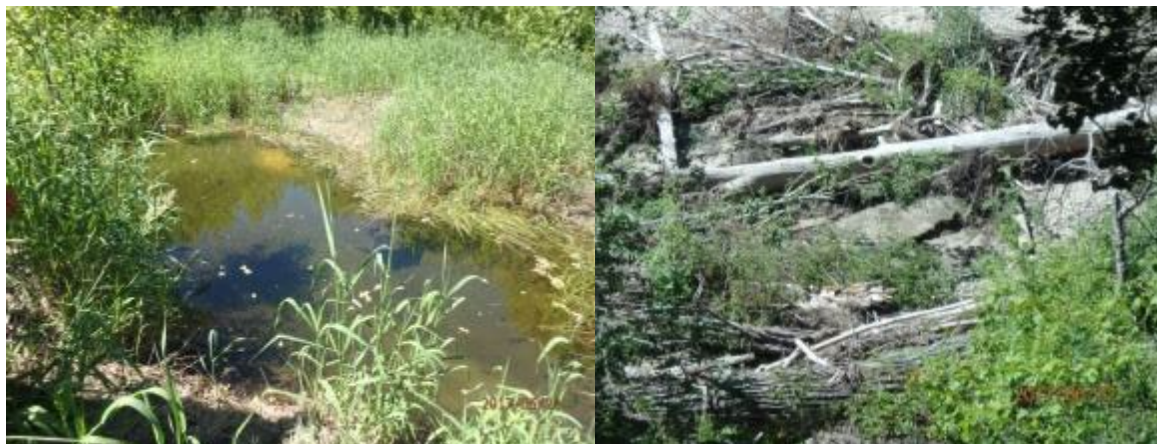
Figure B-24. Floodplain habitats in Sanpoil 5E reach. Left panel shows deep (>1 meter) pool used by amphibians and salmonid fish. Right panel shows large jam stored in the floodplain east of the main channel.

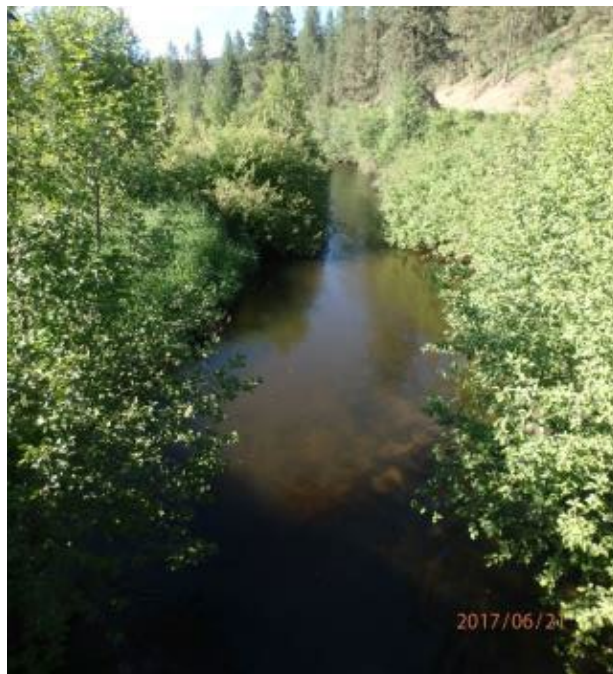
Figure B-26. Photo of the downstream end of Hall 4 reach looking upstream. Note the healthy riparian community.

Location and Site Description: Hall 4 drains approximately 18.4 km² and is approximately 8.9 km from the confluence with the Columbia River. The priority reach is the mainstem Hall Creek and is approximately 5,000 m long (Figure B-25). It runs through a post-glacial valley dominated by forested and emergent wetland. The current creek alignment is largely disconnected from this wetland system on the surface. It is characterized by meandering and straight morphologies, with appropriate physical habitat diversity for a low gradient meandering stream characterized by pool-riffle sequences. Bankfull width averages 10.5 m, while floodplain width ranges from approximately 230 m to 440 m. Average channel gradient is approximately 1%. Despite the high-quality condition of the riparian zone through much of the reach, there is a noticeable lack of LWD in the channel—except in the bottom 1/3 of the reach where LWD loads are higher. At places, the riparian zone is severely impacted by agricultural and probably grazing operations. On the day of our field visit, the stream was highly turbid at the bottom of the reach (Figure B-26). The source of turbidity was not observed.

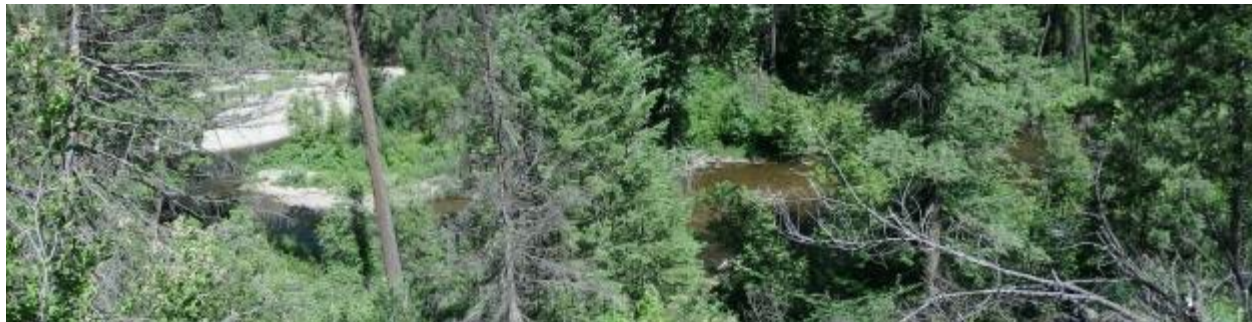
Figure B-28. Upper end of Sanpoil 4G reach. Note fully intact riparian condition and large slug of sediment in the active channel resulting from the April 2017 flood.

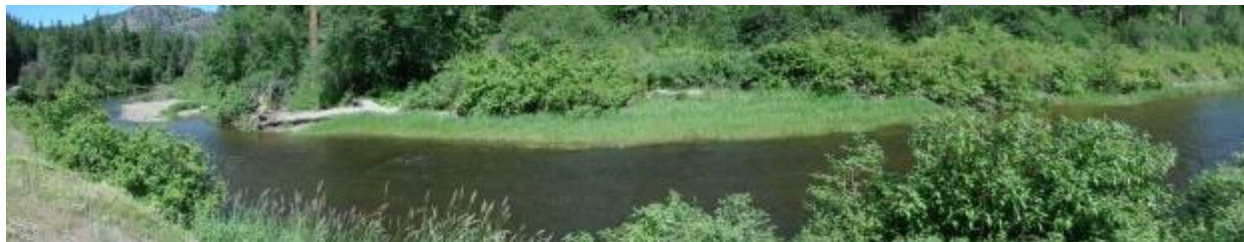
Figure B-29. Representative photo taken near the middle of Sanpoil 4G reach. Note healthy riparian condition but also a relative lack of sediment and LWD in the active channel compared to Figure B-28.

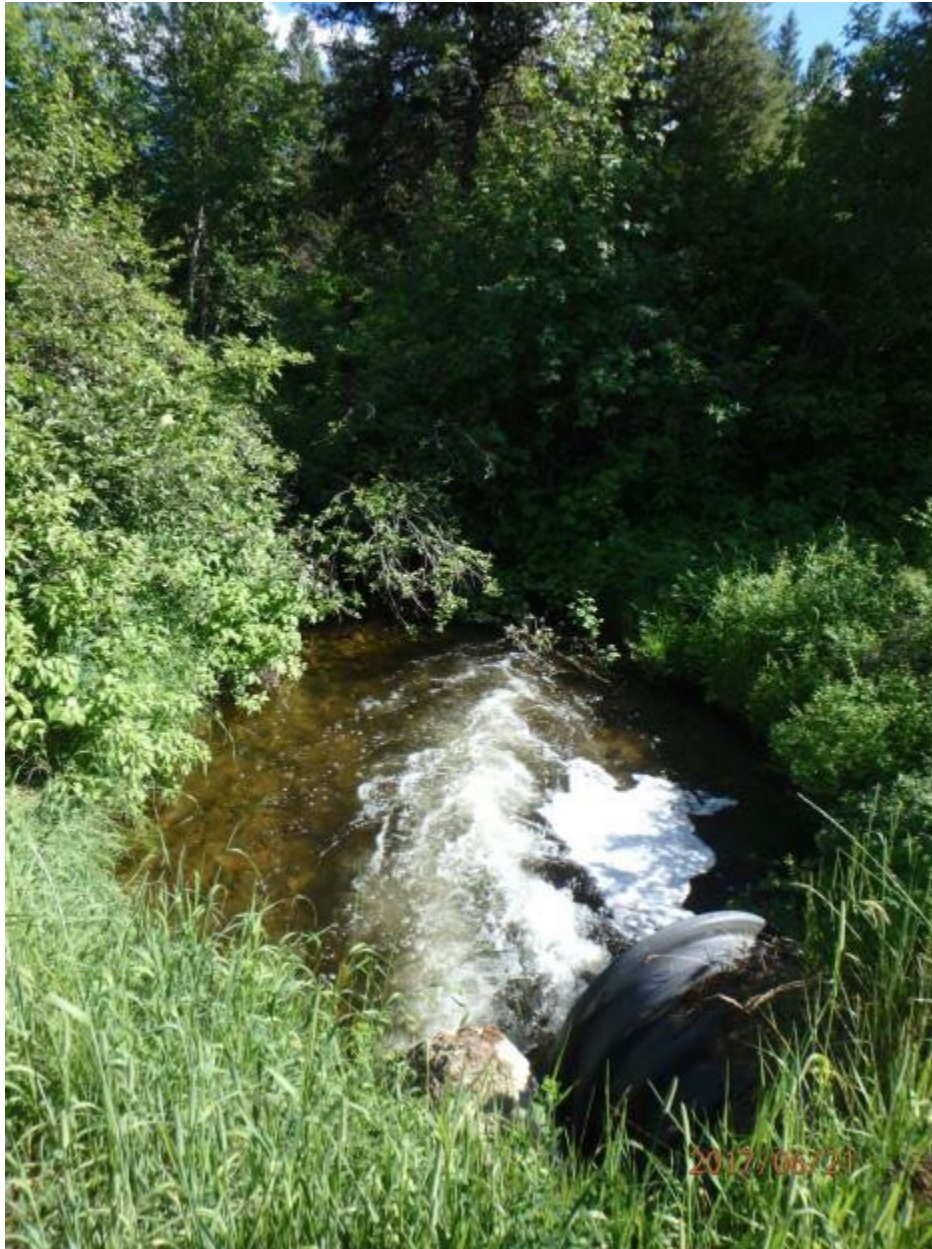
Figure B-31. Culverts at the top of NF Hall 1B reach. These culverts flow under a farm lane that does not appear to be necessary. Removal of these culverts or modification of the outlet with a boulder step configuration could be a relatively inexpensive and easy project.

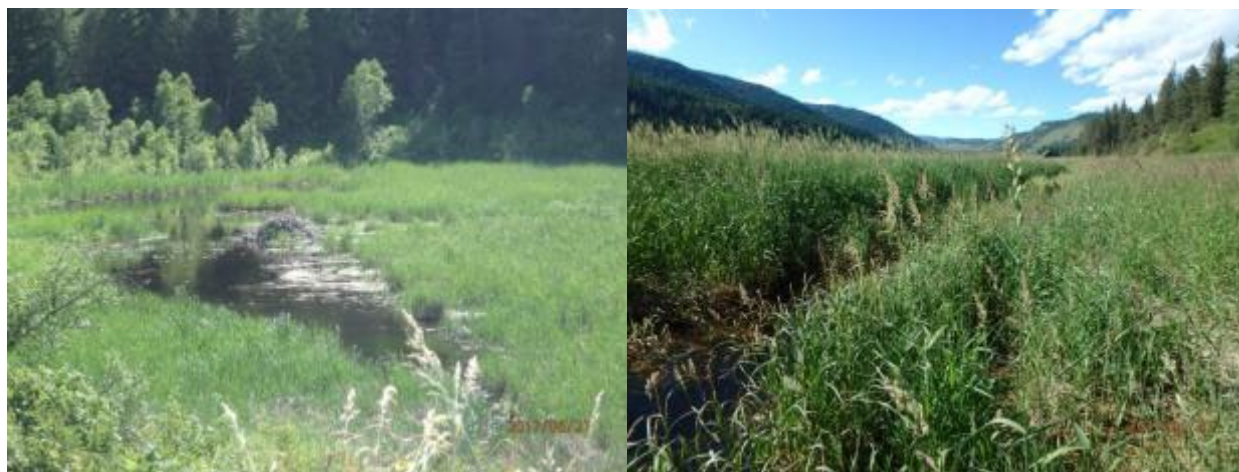
Figure B-32. Beaver lodge and flooded wetland near the middle of NF Hall 1B reach (left panel). Reed canary grass monoculture choking the stream, with no visible flow at the bottom end of the reach (right panel).

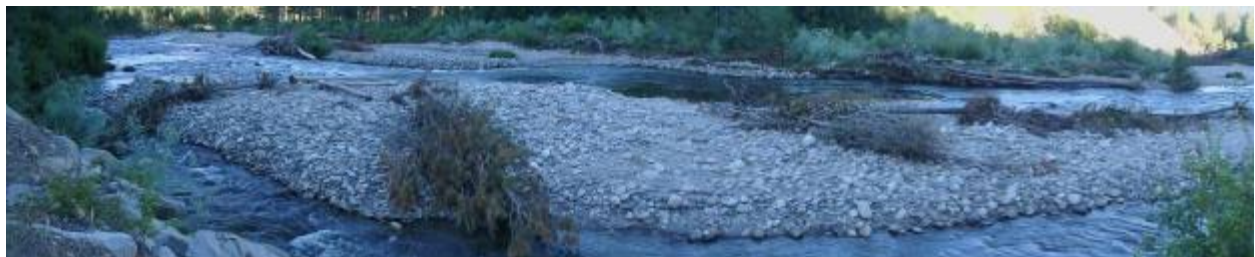
Figure B-34. Gravel and LWD deposited in the channel during the 2017 flood event near the downstream end of Sanpoil 2F reach.

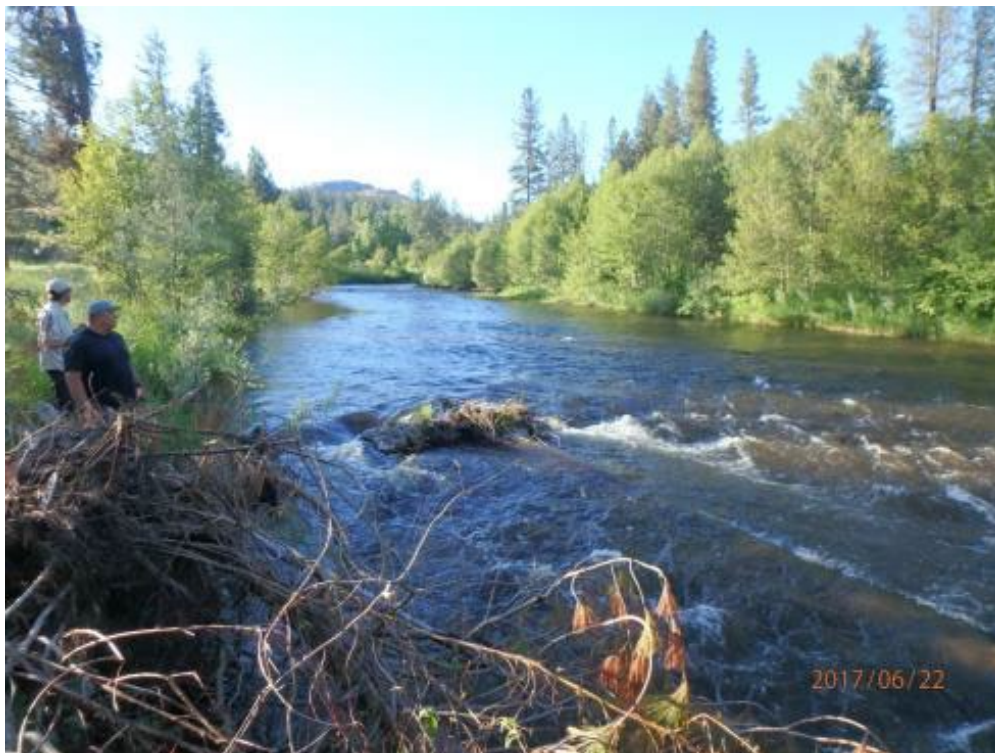
Figure B-35. Looking upstream from the park on the west side of the river just upstream of Bush Creek Road. Note the lack of LWD in the channel here. This is typical of the reach.

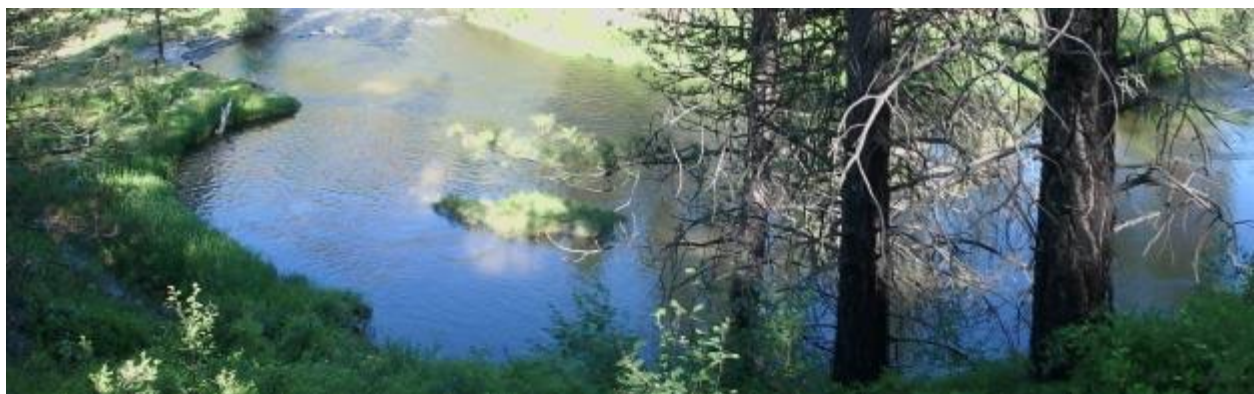
Figure B-37. Pool, glide, riffle sequence in the center of Sanpoil 2J reach. This level of habitat diversity is typical of the reach. Note nearly complete lack of LWD in the channel.

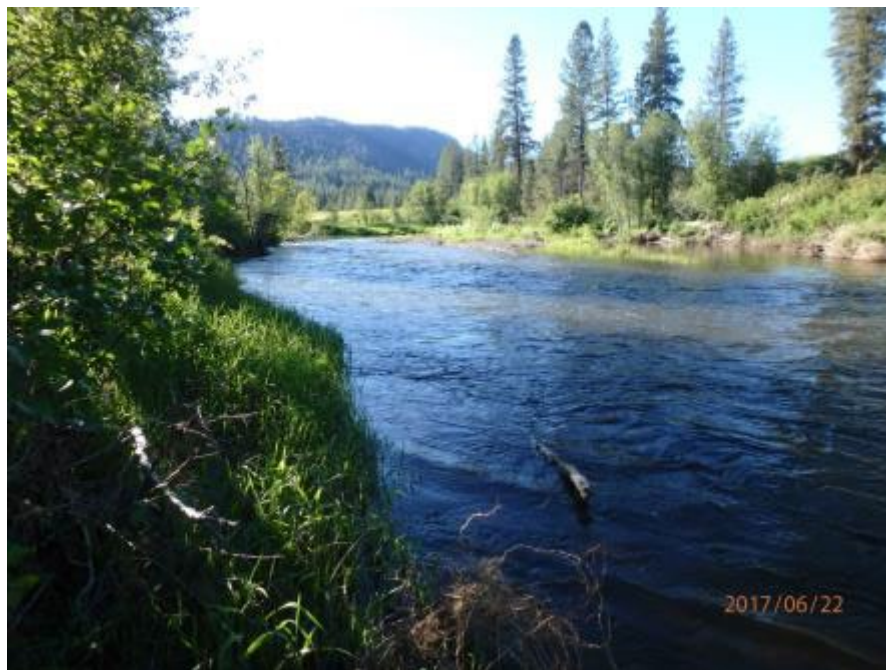
Figure B-38. Sanpoil 2J reach, looking upstream. Riparian zone is in fair condition but lacks mature trees throughout the reach.

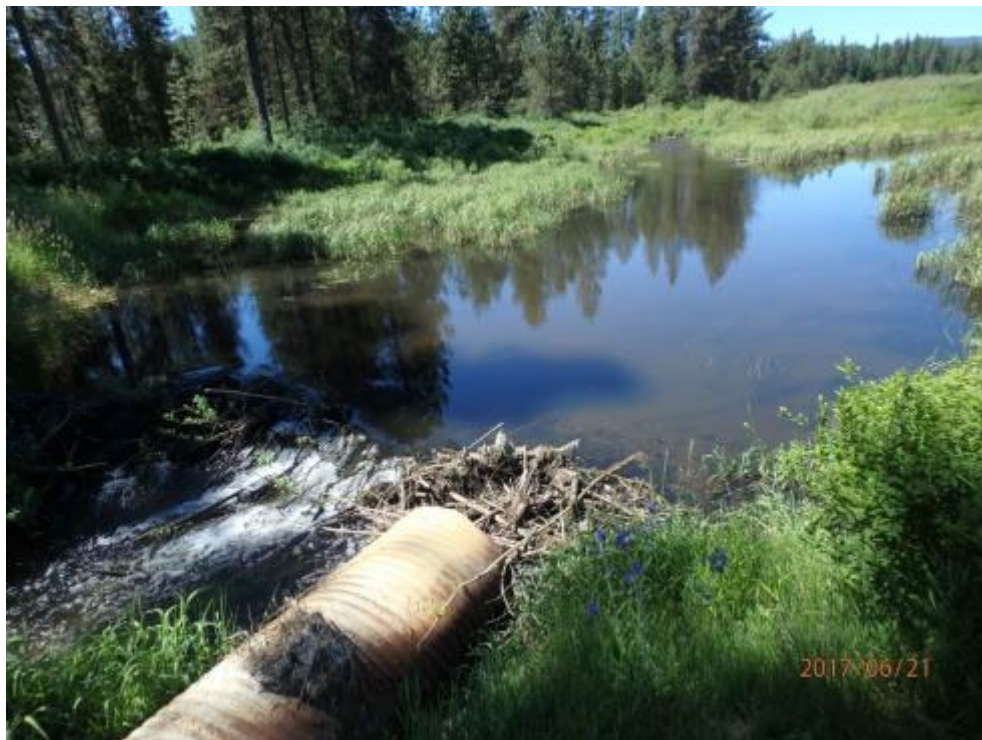
Figure B-40. Beaver dam and failed culvert at the bottom of Stranger 7 reach. This photo is representative of low gradient stream meandering through densely vegetated wetland. Numerous juvenile salmonids were observed on the margins of the channel here.

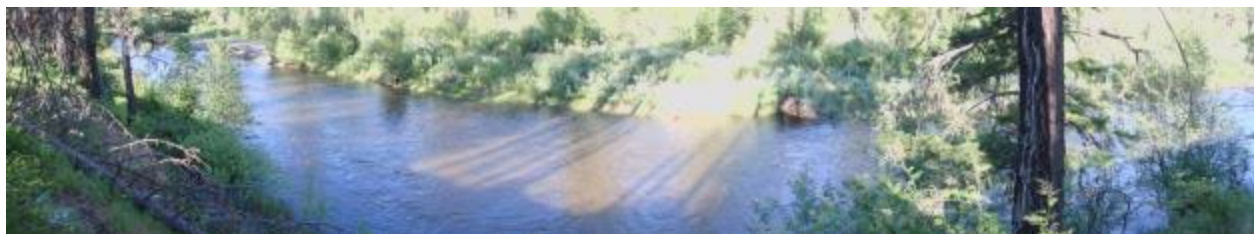
Figure B-42. Panoramic photo of a representative section of the study reach in the upper 1/2 of the reach. Note the relatively high quality riparian condition. Also, the river here is largely one large glide with very little LWD in the channel.

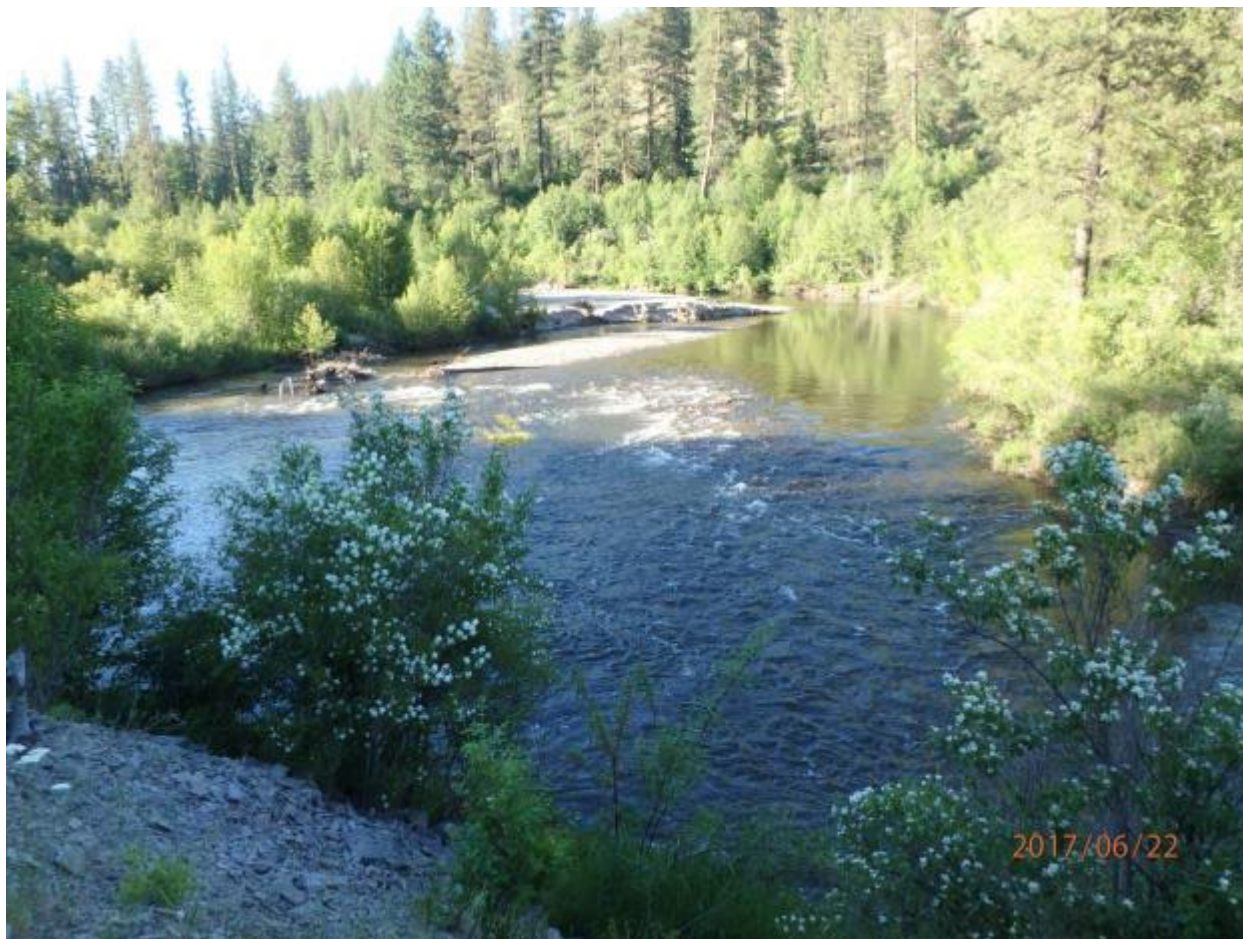
Figure B-43. Photo taken near SR 21 in the lower 1/3 of the study reach. This is a good candidate location for an engineered log jam installation to engage floodplain habitats on the other side of the channel and to protect the road on the near side.
