2022 UPPER COLUMBIA AND SANPOIL HABITAT RESTORATION PLAN

Prepared for:
Confederated Tribes of the Colville Reservation

Prepared by:
Phil Roni, Ph.D., Kai Ross, Ph.D., and Raymond K. Timm, Ph.D.,

Revised Final Report April 11, 2022

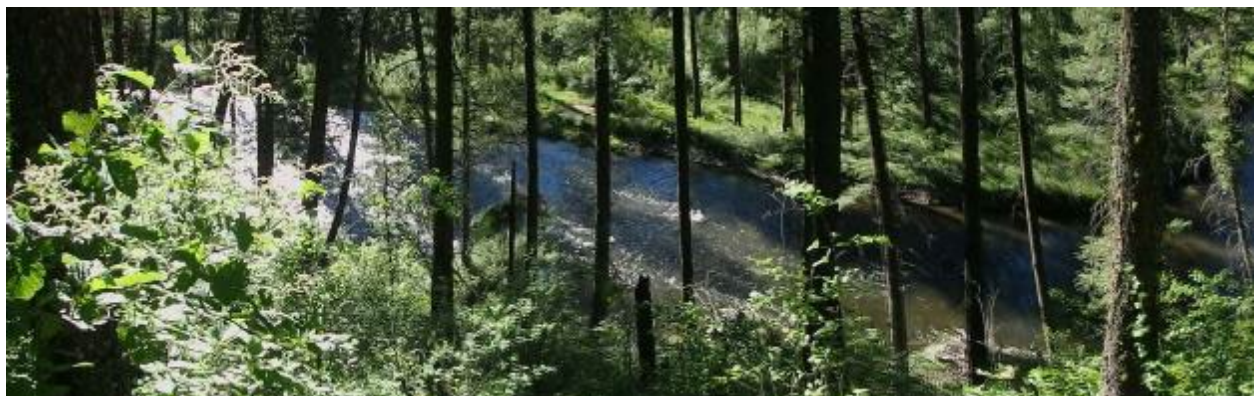
Figure B-45. Representative photo of Sanpoil 3C reach showing intact riparian forest, single-thread riffle habitat, and the lack of instream LWD.

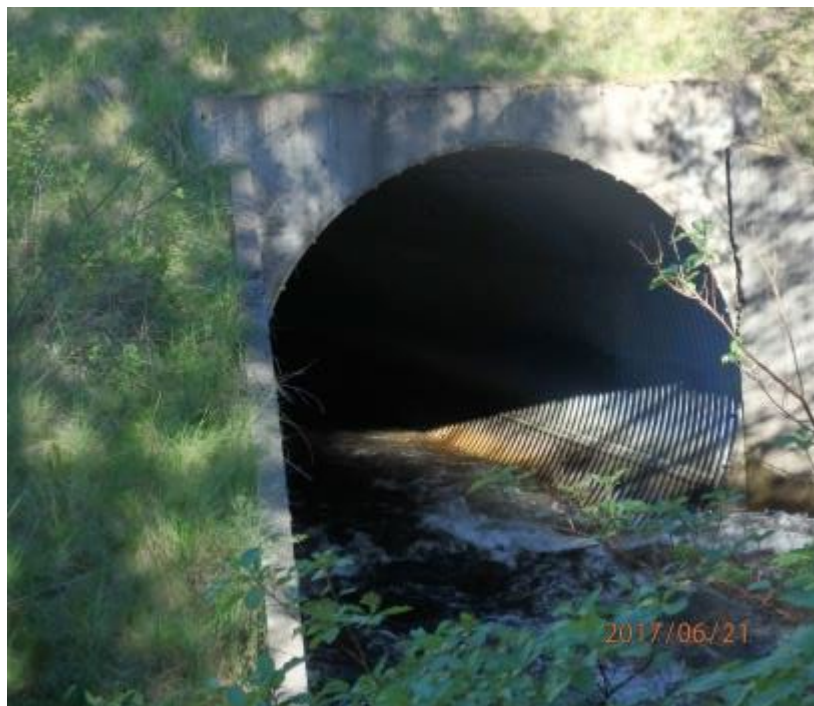
Figure B-47. Large culvert at the bottom of Hall 2B reach.

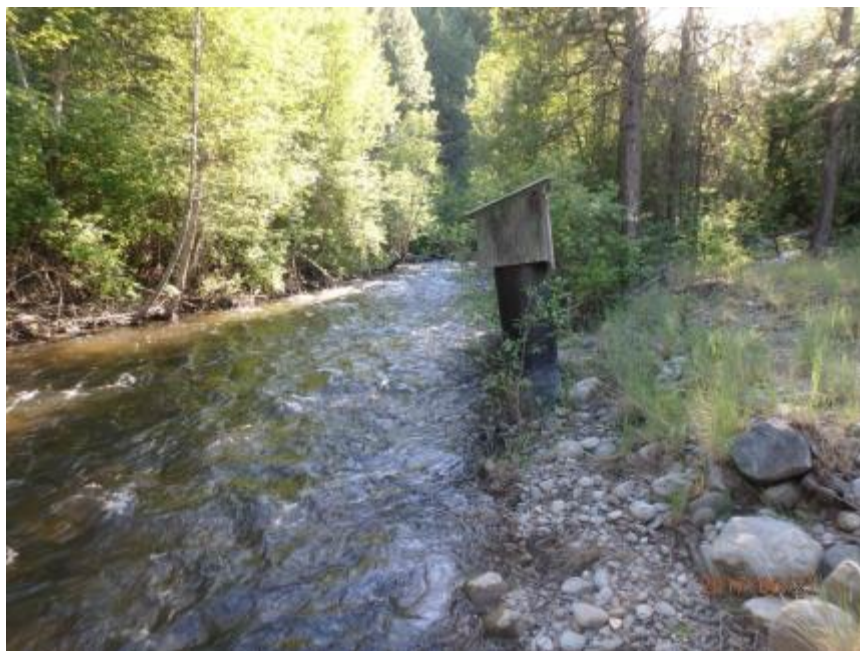
Figure B-48. Priority Hall 2b reach. This reach is characterized by large gravel and cobble substrate and relatively steep gradient. Note the lack of LWD in the channel.

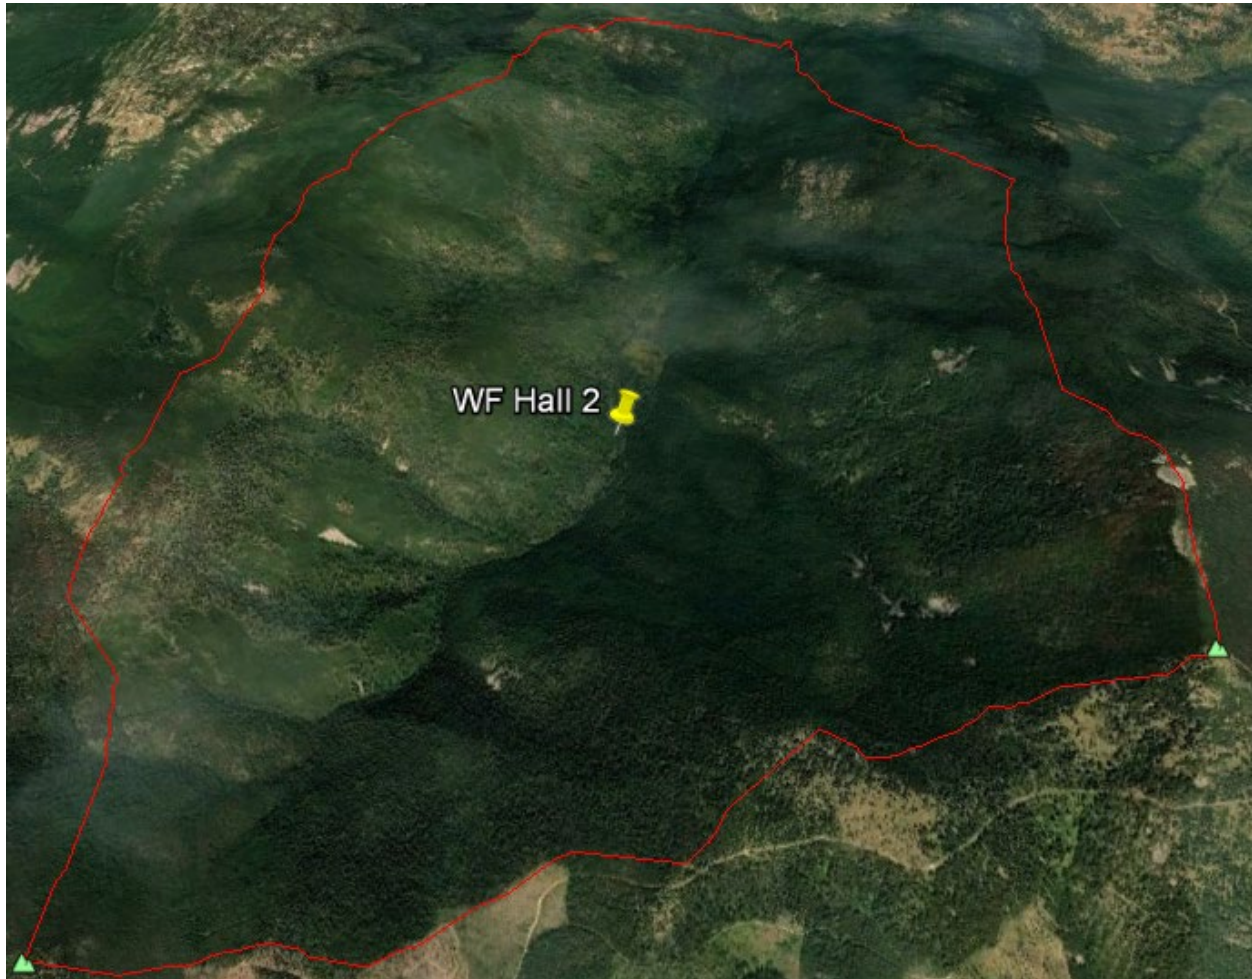
Reach Name: WF Hall 2

Figure B-50. Overview of WF Hall 2 reach. Note that roughly the western half of this EDTshed was logged completely in the last decade. Red lines indicate the upslope areas draining to the reach.

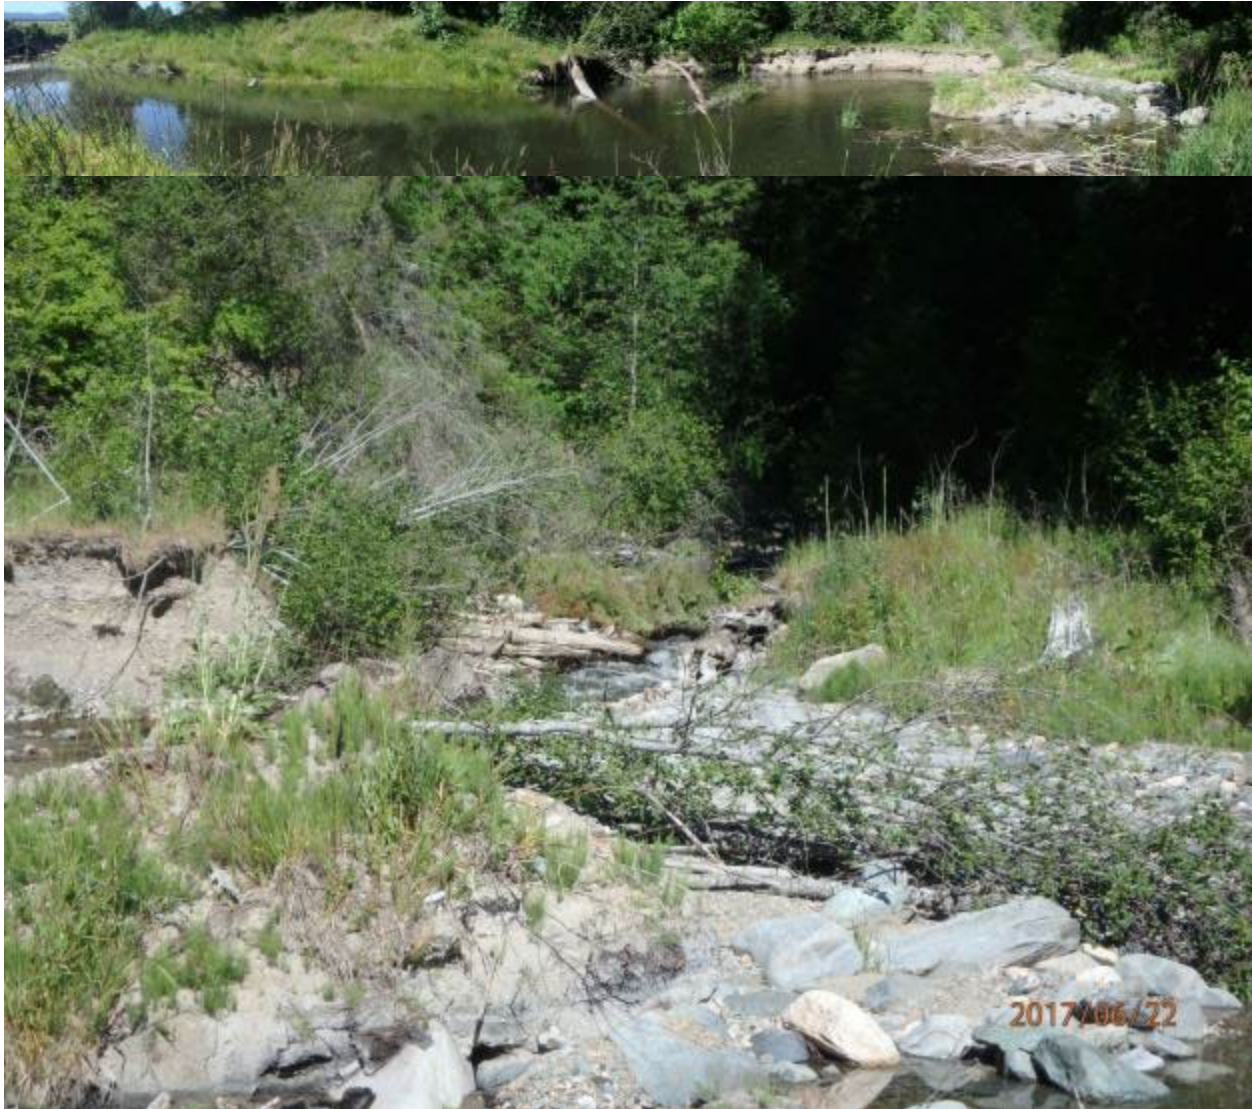
Figure B-52. Barnaby Creek near confluence with Lake Roosevelt. Upper panel is a panoramic of the pool impounded by the Inchelium Highway. Note the LWD and eroded bank. Lower panel is a view upstream from the pool at an active landslide that recruited trees to the channel during the April 2017 storm.

Active landslides and road failures due to the April 2017 storm delivered a lot of sediment to this system. It is not known if the proximity of Barnaby Creek Road results in a chronic source of fine sediment. Land ownership has not been verified. Some industrial forestry happens in this EDTshed and may be privately owned.

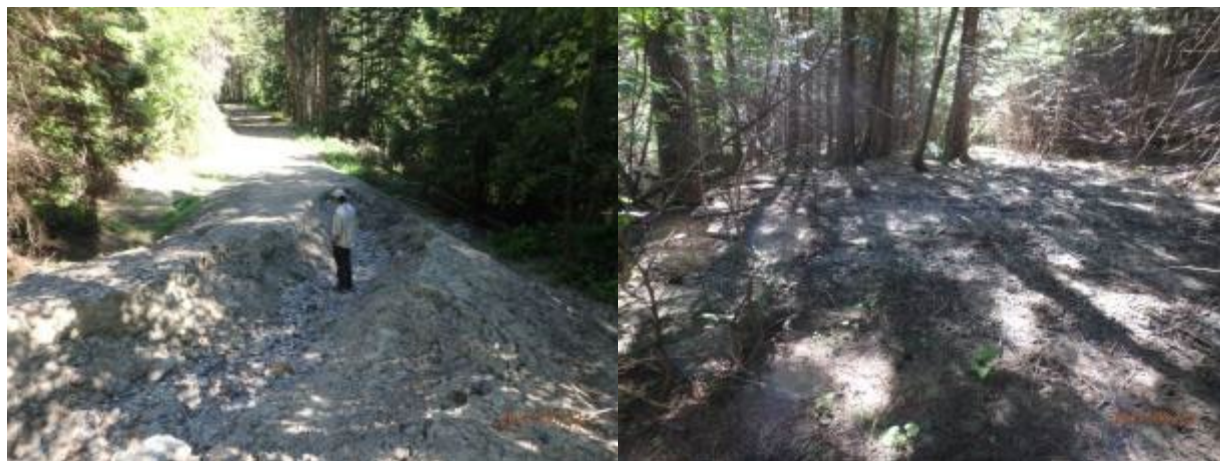
Figure B-53. Roadbed erosion caused during April 2017 storm (left panel). Right panel shows road sediments delivered across the forested riparian zone directly to Barnaby Creek.

Location and Site Description: Barnaby 1 drains approximately 4 km² and discharges directly to Lake Roosevelt. The priority reach is approximately 1,400 m long. It is characterized by plane-bed, pool-riffle, and step-pool channel morphology. Bankfull width is approximately 2 m, while floodplain width is approximately 25 m. Average channel gradient varies with channel type and ranges between approximately 3% and 12.5%. The bottom of the reach is in good condition due to recent landslide disturbance and LWD recruitment to the channel and pool upstream of the Inchelium Highway culverts (Figure B-52). The stream habitat and riparian vegetation in this reach are generally in high quality condition. The riparian zone is comprised of mature conifers throughout. There has been a history of logging throughout the lands that drain to this reach and some recent road failures were documented during our field visit. Just below the confluence with Cedar Creek, a substantial delivery of road sediment occurred, resulting from the April 2017 storm (Figure B-53). While this specific road failure is not within the study reach, sediment was transported across the riparian zone and was delivered directly to the stream channel. It's not known if this impact propagated downstream to the priority reach. Regardless, the road failure needs to be addressed.

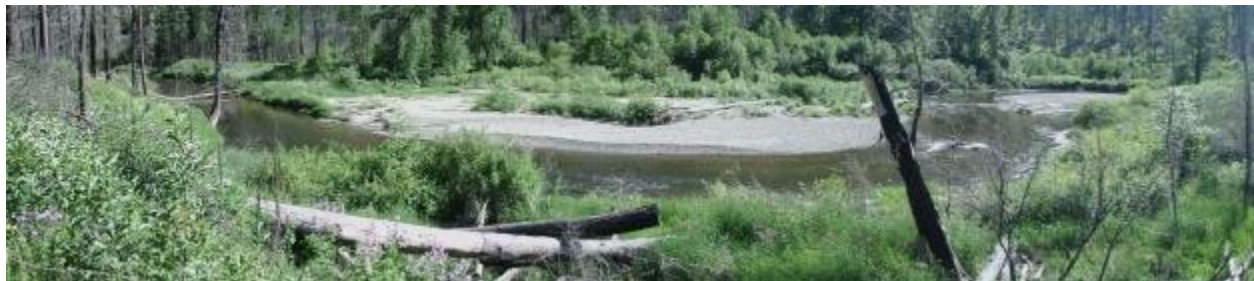
Figure B-55. Representative habitat quality of Sanpoil 4C reach. Lots of gravel and LWD interactions are apparent as the river meanders across the valley floor.

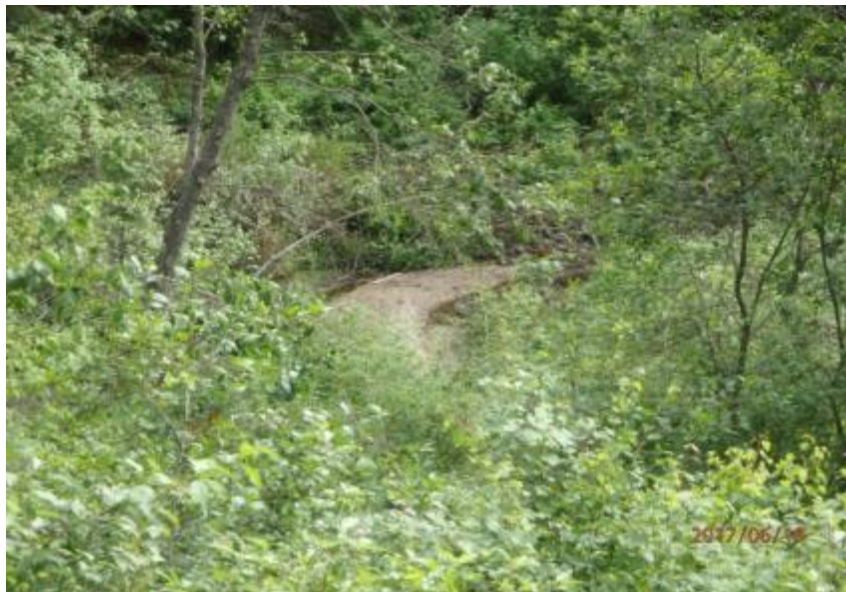
Figure B-57. Photo taken near the top of Silver 1 study reach. Note the healthy and intact riparian zone. Also, there is substantial fine sediment in the channel (center of photo) from the nearby road or possibly from recent logging of steep slopes above the study reach.

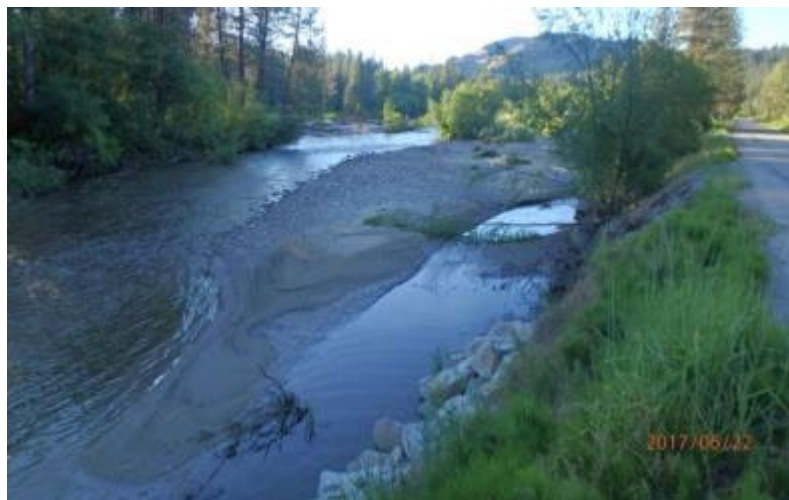
Figure B-59. Site of potential ELJ installation. In this location, the river has migrated into the road prism. An ELJ here would encourage the river to move into the floodplain on the opposite bank while protecting the road. Note high quality and diverse habitat in the channel and riparian conditions.

This reach is highly laterally active. This creates opportunities, but it can also be risky. An engineer should be consulted prior to installing structures in the channel where they might cause the river to interact with road infrastructure. ELJs may be appropriate to restore habitat in the channel as well as to divert flows away from eroding road prisms. The river is engaging the toe of the Silver Creek Road prism in several places in this reach, which may create cooperation opportunities with departments of transportation. LWD in a bio revetment installation would protect the toe, and strategic ELJs in the reach would facilitate moving the river away from the road in general. There are no bridges or buildings downstream that would be at risk. In addition, there is at least one large active landslide in the reach, with a house above it where another ELJ might be used to protect the toe of that slope.

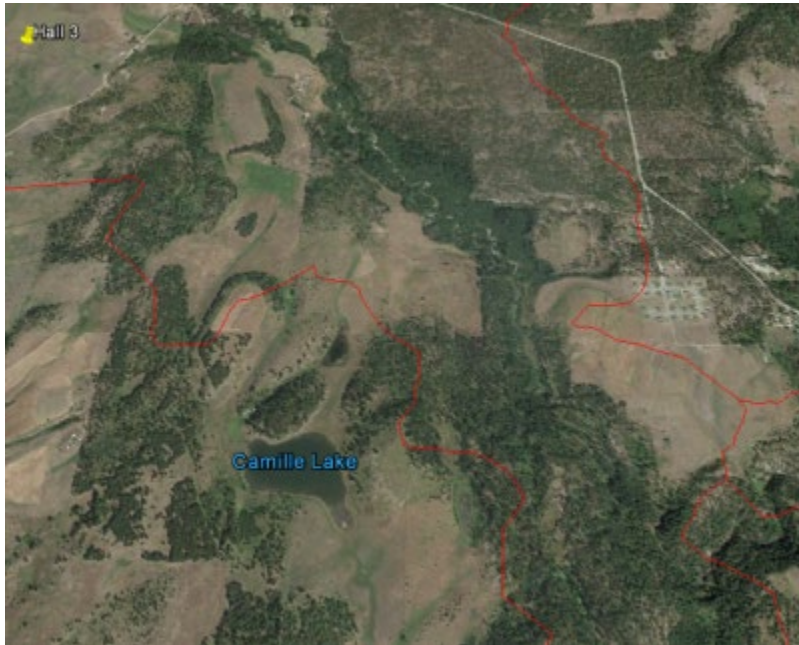
Figure B-60. Overview of Hall 3 reach. This long (9.4 km) reach drains through a variety of private lands and others of unknown ownership. The red line indicates the upslope area that drains to the stream here.

Location and Site Description: Hall 3 drains a large area (approximately 27 km²) and is approximately 2.7 km from the confluence with Lake Roosevelt. The priority reach is the mainstem of Hall Creek and is approximately 7,100 m long (Figure B-60). It is characterized predominantly by meandering morphology, but exhibits both confined and island-braided morphologies as well, mostly in the lower extents. Bankfull width is approximately 12 m, while floodplain width is between approximately 30 m and 150 m. Average channel gradient varies between approximately 0.6% and 2.9%. There is a large, deep pool at the top of the reach upstream of the Lynx Creek Bridge. Inputs of road sediment are apparent from this bridge and road intersection. There is dense shrubby riparian vegetation throughout the reach (Figure B-61). However, there are some riparian impacts near the top of the reach where the stream abuts agricultural lands. In addition, there are clearly fine sediment inputs into the system here. LWD loads are moderate, on average. The channel is relatively straight with homogeneous habitat units, except where LWD is present in the channel (Figure B-61). During the April 2017 floods, overbank flows extended out into the floodplain and engaged historic channel features (Figure B-62).

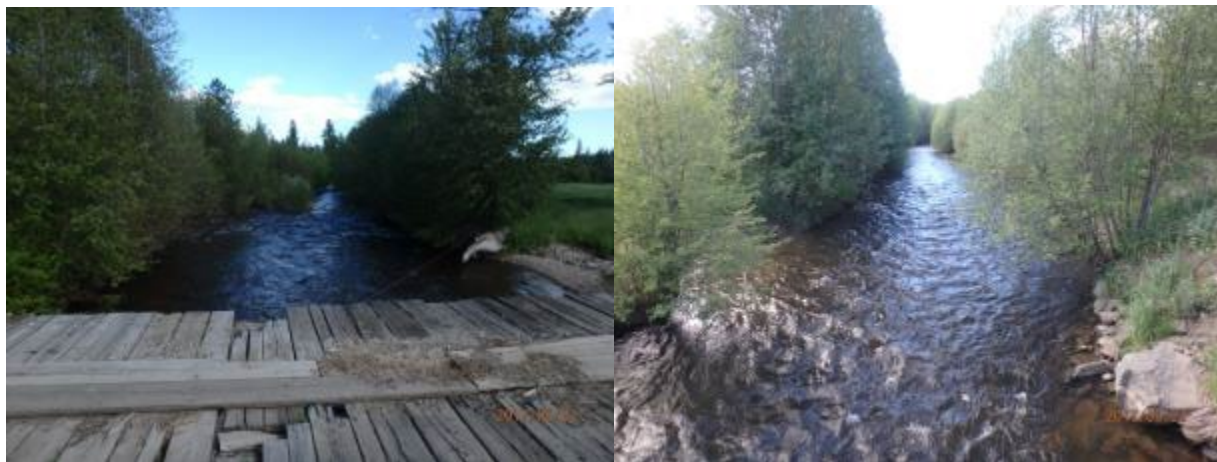
Figure B-61. Looking downstream (left panel) and upstream (right panel) from the approximate center of Hall 3 reach. Conditions in this location are typical of the reach.

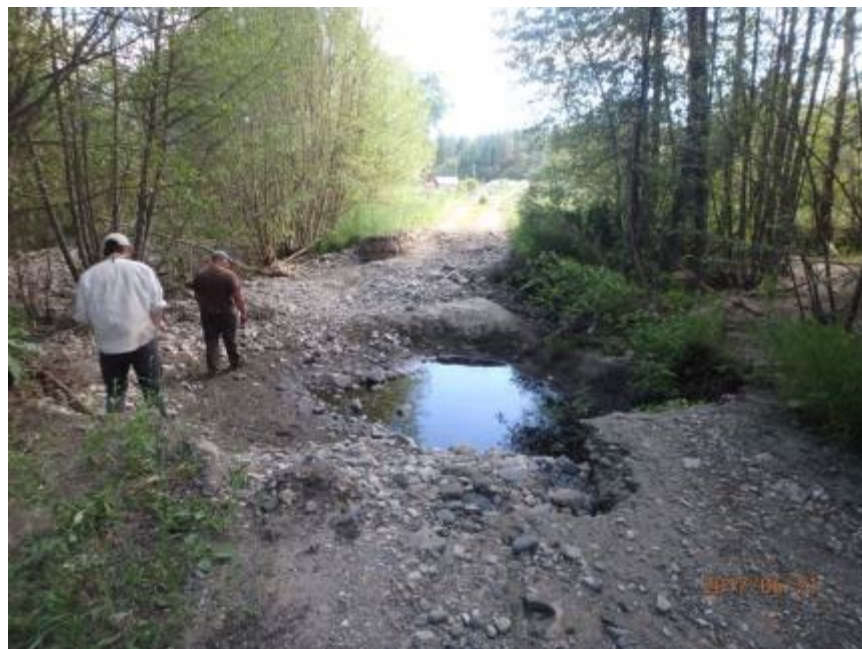
Figure B-62. Evidence of floodplain activation during April 2017 flood events. The road washed out here as the creek engaged a historic channel and sediment was delivered to the floodplain for several hundred meters downstream.
